**PEUGEOT 308: 1GS170**

**Limited Technical Inspection**

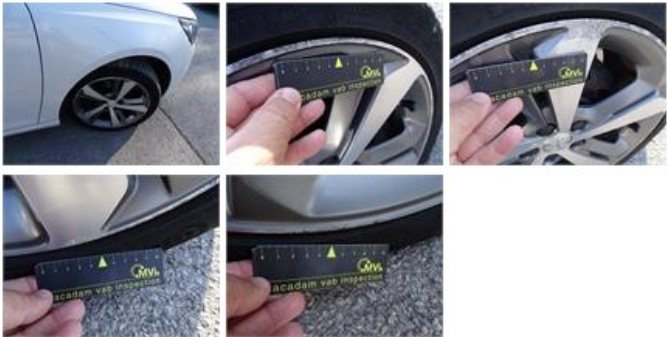
Alloy rim R L, Rust, Acceptable	0,00
<i>No pictures to display</i>	
Door catch R L, Not functioning (well), P - Check	0,00
<i>No pictures to display</i>	
Door catch R R, Not functioning (well), P - Check	0,00
<i>No pictures to display</i>	
Alloy rim F R, Scratch(es), LI - Repair and paint (complete)	95,00
