BMW 5 BERLINE: UF4629

Limited Technical Inspection

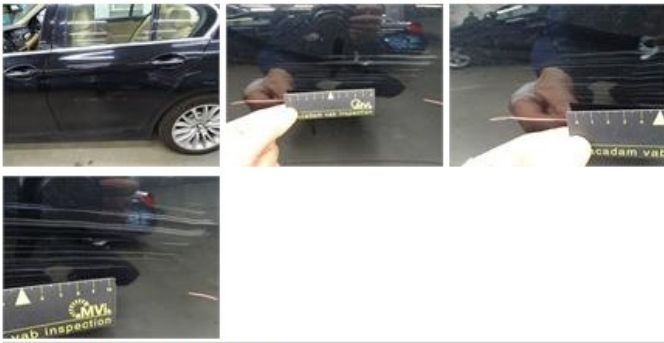
Total cost ex VAT	572,02
Door R L, Scratch(es), LI - Repair and paint (complete)	382,02

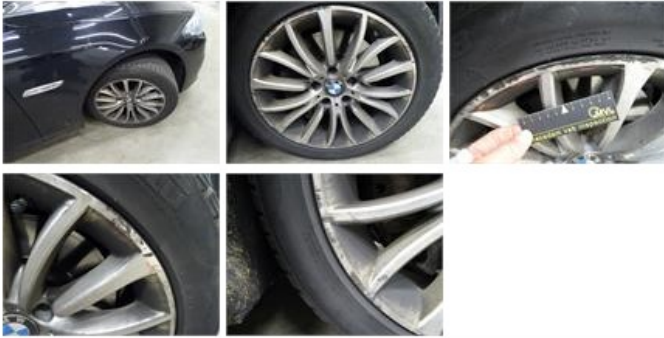
Door R R, Dent(s), Acceptable	0,00
<i>No pictures to display</i>	
Bumper F, Scratch(es), Acceptable	0,00
<i>No pictures to display</i>	
Alloy rim F L, Scratch(es), Acceptable	0,00
<i>No pictures to display</i>	
Alloy rim F R, Scratch(es), LI - Repair and paint (complete)	95,00

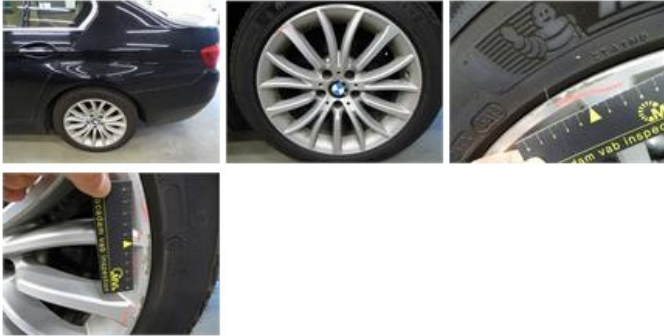
Door F R, Dent(s), Acceptable	0,00
<i>No pictures to display</i>	
Alloy rim R L, Scratch(es), LI - Repair and paint (complete)	95,00
