BMW 3: 1FQQ732

Limited Technical Inspection

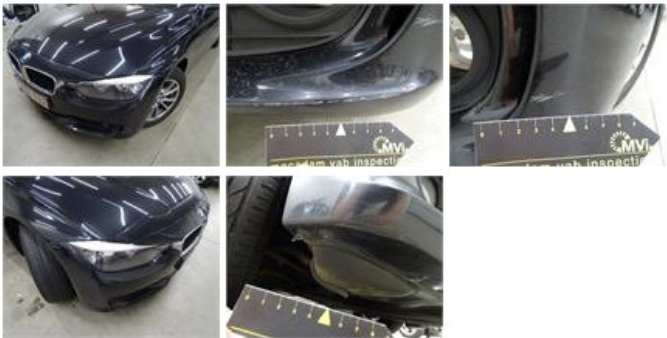
Ignition key, Missing, E - Replace	0,00
<i>No pictures to display</i>	
Bumper F, Scratch(es), LI - Repair and paint (complete)	211,80
