BMW 3 BERLINE: 1KFG990

Limited Technical Inspection

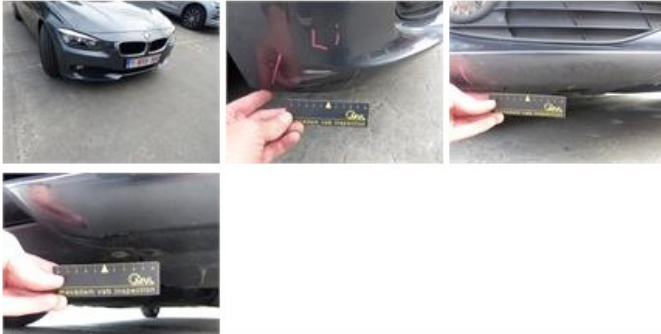
<i>No pictures to display</i>	
Rear bulkhead lining, Scratch(es), Acceptable	0,00
<i>No pictures to display</i>	
Maintenance book, Missing, Acceptable	0,00
<i>No pictures to display</i>	
Outer backrest protection L, Scratch(es), Acceptable	0,00
<i>No pictures to display</i>	
Wing R L, Dent(s), Acceptable	0,00
<i>No pictures to display</i>	
Door R L, Dent(s), Acceptable	0,00
<i>No pictures to display</i>	
Bumper F, Scratch(es), LI - Repair and paint (complete)	211,80

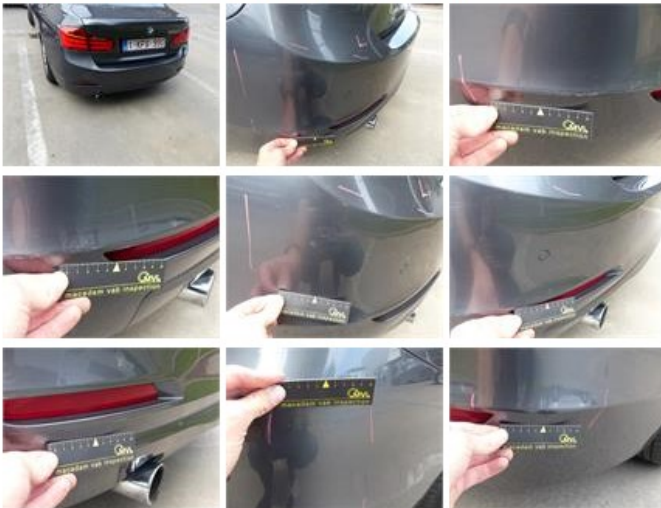
Tailgate, Scratch(es), Acceptable	0,00
<i>No pictures to display</i>	
Alloy rim R L, Scratch(es), Acceptable	0,00
<i>No pictures to display</i>	
Door F R, Scratch(es), Acceptable	0,00
<i>No pictures to display</i>	
Wing R R, Dent(s), Acceptable	0,00
<i>No pictures to display</i>	
Rearview mirror basis R, Scratch(es), Acceptable	0,00
<i>No pictures to display</i>	
Outer backrest protection R, Scratch(es), Acceptable	0,00
<i>No pictures to display</i>	
Bumper R, Scratch(es), LI - Repair and paint (complete)	211,80
