RENAULT Grand Scenic: 1GRY592

Limited Technical Inspection

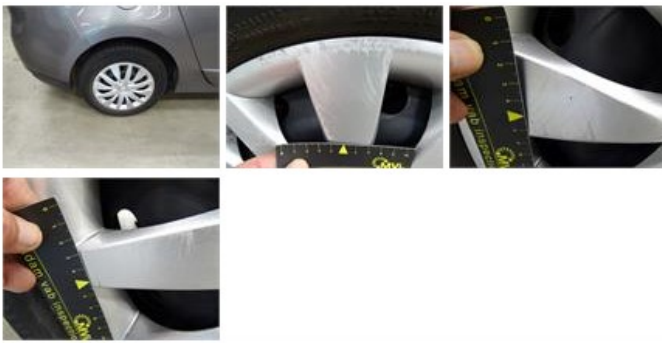
Wheel cover R R, Scratch(es), E - Replace	30,00
---	-------

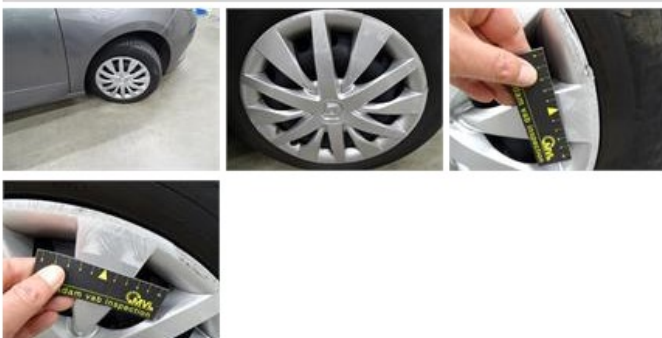
Wing R R, Scratch(es), Acceptable	0,00
<i>No pictures to display</i>	
Backrest cover R M, Scratch(es), Acceptable	0,00
<i>No pictures to display</i>	
Bonnet, Repaired, Acceptable	0,00
<i>No pictures to display</i>	
Bumper R, Scratch(es), Acceptable	0,00
<i>No pictures to display</i>	
Rocker panel inner R R, Scratch(es), Acceptable	0,00
<i>No pictures to display</i>	
Wheel cover F R, Scratch(es), E - Replace	30,00
