AUDI A3 SPORTBACK: 1RRB519

Limited Technical Inspection

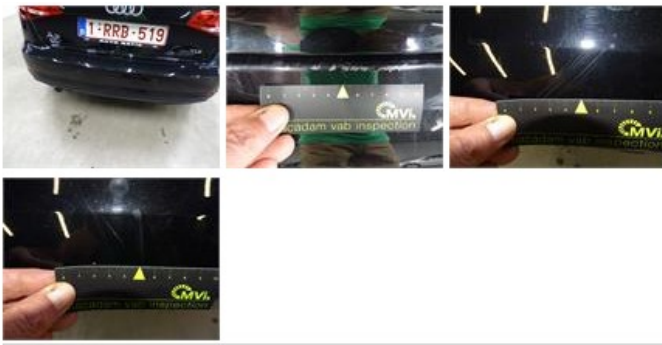
Total cost ex VAT	1106,65
Door R R, Scratch(es), Acceptable	0,00
<i>No pictures to display</i>	
Bumper R, Scratch(es), LI - Repair and paint (complete)	211,80
