AUDI A5: 1HDZ466

Limited Technical Inspection

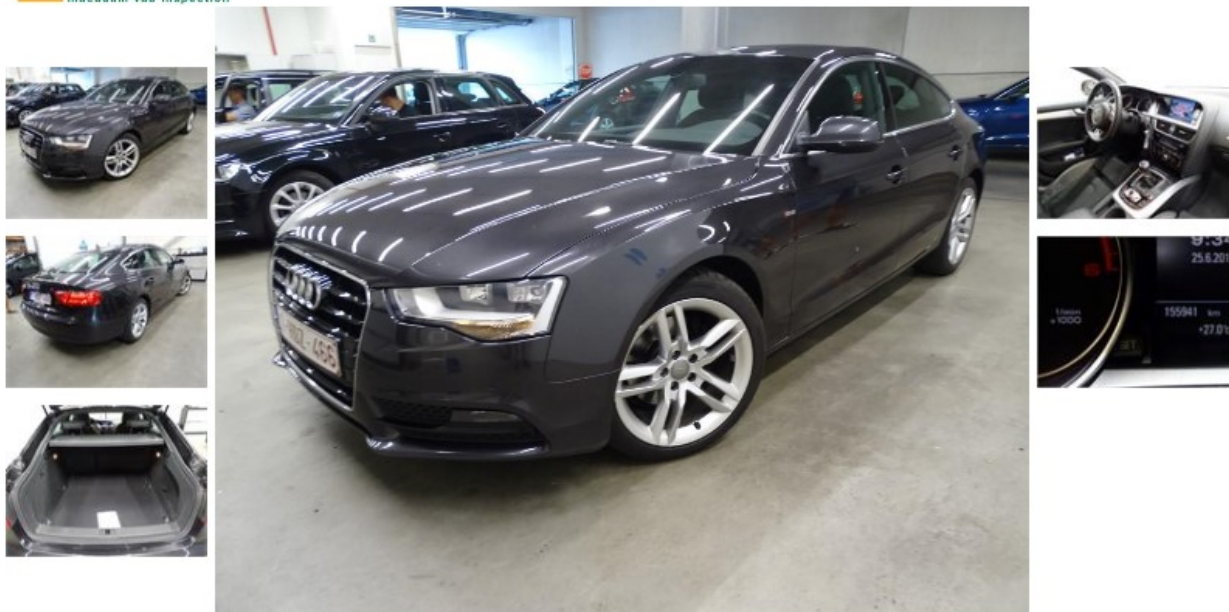
Vinnumber:	WAUZZZ8T2FA001943	Versionname:	A5 SB TDie S-line DPF 136PK
First Registrationdate:	27/06/2014	Fiscalpower:	
Expertise Mileage:	155941	Power Kw:	100
Bodytype:		Body color:	Anthracite
Gearbox:	MAN 6 VIT	Paint type:	Metalic
Transmission:	Front	Rims summer:	Aluminium
Fueltype:	Diesel	Oil level:	OK
Battery functioning:	Yes	Parking lot:	4110
Number of doors:	5		
Number of seats:	5		
Number head rests:	5		
Rims summer:	Aluminium		
Category:	Passenger Car		
Oil level:	OK		
Registration Certificate Car (BE):	Yes
