<b>BMW 3: 1GWD504</b>			
Vinnumber:	<b>WBA3E11090F560337</b>	Versionname:	<b>3 BER 320d Eff.Dynamics Ed.163PK</b>
First Registrationdate:	<b>16/05/2014</b>	Fiscalpower:	
Expertise Mileage:	<b>157056</b>	Power Kw:	<b>120</b>
Bodytype:	<b>Berline</b>	Body color:	<b>Black</b>
Gearbox:	<b>MAN 6 VIT</b>	Paint type:	<b>Metalic</b>
Transmission:	<b>Back</b>	Rims summer:	<b>Aluminium</b>
Fueltype:	<b>Diesel</b>	Oil level:	<b>OK</b>
Battery functioning:	<b>Yes</b>	Parking lot:	<b>3505</b>
Number of doors:	<b>4</b>		
Number of seats:	<b>5</b>		
Number head rests:	<b>5</b>		
Rims summer:	<b>Aluminium</b>		
Category:	<b>Passenger Car</b>		
Oil level:	<b>OK</b>		
Registration Certificate Car (BE):	<b>Yes</b>

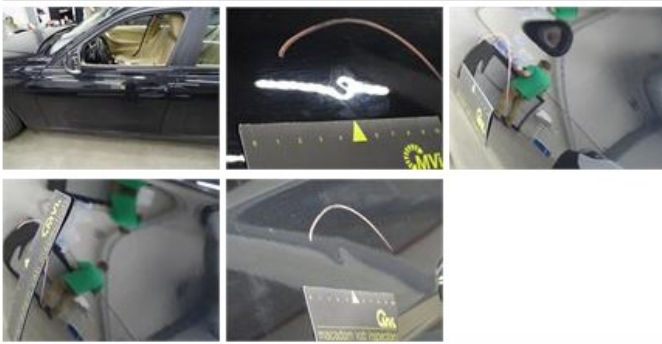
<b>Total cost ex VAT</b>	<b>189,00</b>
<b>Bonnet, Stone chip(s), Acceptable</b>	<b>0,00</b>
<i>No pictures to display</i>	
<b>Door F L, Dent(s), PDR - Paintless dent repair</b>	<b>63,00</b>

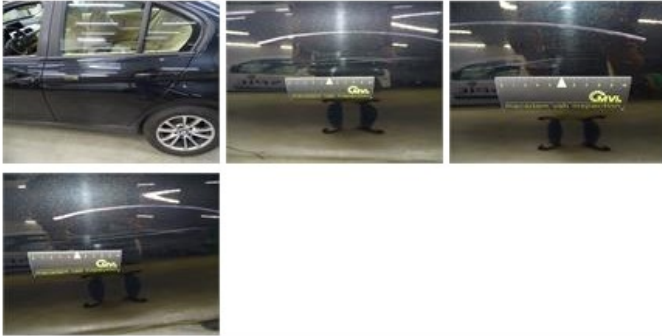
Door R L, Scratch(es), Acceptable 0,00
