**VOLVO XC60: 1KRJ361**

**Limited Technical Inspection**

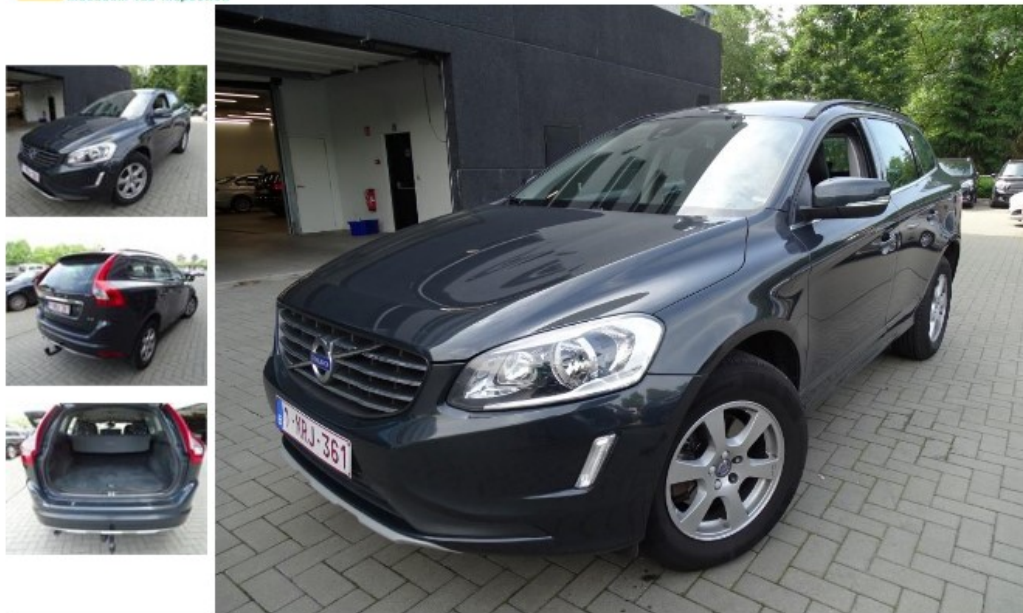
Vinnumber:	<b>VV1DZARC1G2783533</b>	Versionname:	<b>2.0 D3 2WD MOMENTUM</b>
First Registrationdate:	<b>16/06/2015</b>	Fiscalpower:	
Expertise Mileage:	<b>133884</b>	Power Kw:	<b>110</b>
Bodytype:	<b>SUV</b>	Body color:	<b>Grey</b>
Gearbox:	<b>MAN 6 VIT</b>	Paint type:	<b>Metalic</b>
Transmission:		Rims summer:	<b>Aluminium</b>
Fueltype:	<b>Diesel</b>	Oil level:	<b>OK</b>
Battery functioning:	<b>Yes</b>	Parking lot:	<b>4832</b>
Number of doors:	<b>5</b>		
Number of seats:	<b>5</b>		
Number head rests:	<b>5</b>		
Rims summer:	<b>Aluminium</b>		
Category:	<b>Passenger Car</b>		
Oil level:	<b>OK</b>		
Registration Certificate Car (BE):	<b>Yes</b>
