SEAT LEON ST: 1LAR371

Limited Technical Inspection

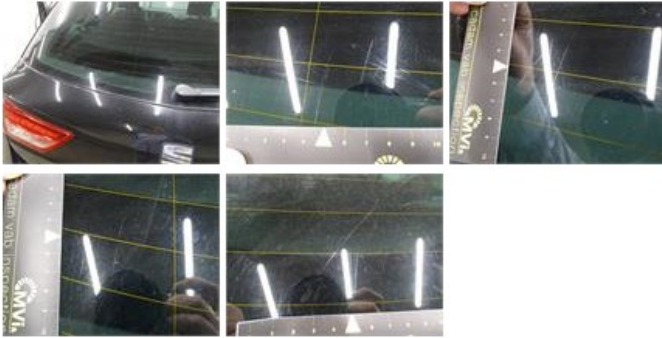
Bumper F, Scratch(es), Acceptable	0,00
<i>No pictures to display</i>	
Wing R R, Dent(s) and scratch(es), Acceptable	0,00
<i>No pictures to display</i>	
Rear window, Scratch(es), E - Replace	0,00
