AUDI A4 AVANT: 1PGV073

Limited Technical Inspection

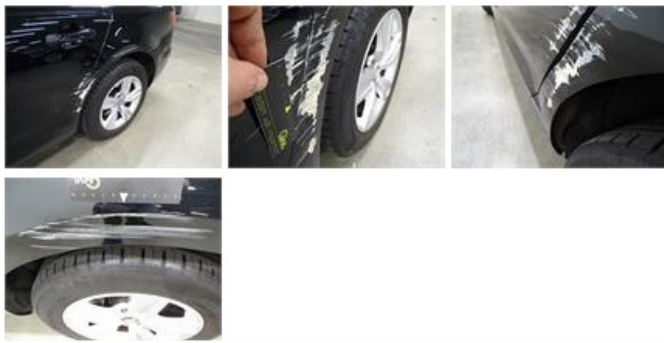
Total cost ex VAT	2258,46
Door F L, Repaired, Acceptable	0,00
<i>No pictures to display</i>	
Wing R L, Dent(s) and scratch(es), Le - Replace and paint	1231,51

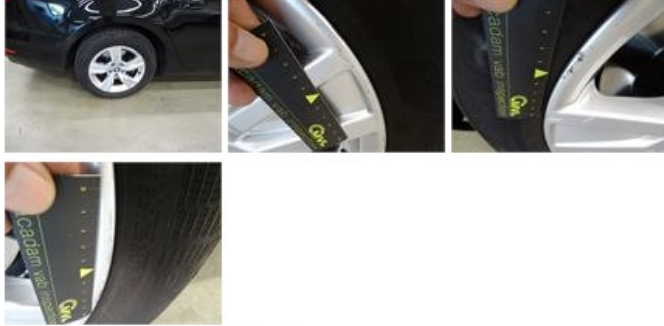
Alloy rim R R, Scratch(es), LI - Repair and paint (complete)	95,00
--	-------
