OPEL Zafira: 1HTD384

Limited Technical Inspection

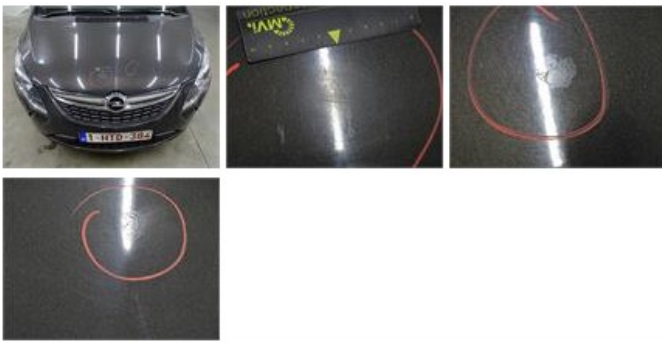
Total cost ex VAT	2091,58
Ignition key, Missing, E - Replace	150,00
<i>No pictures to display</i>	
Wing F R, Scratch(es), 67 - Polish	0,00
<i>No pictures to display</i>	
Bonnet, Chemical polution, LI - Repair and paint (complete)	290,08

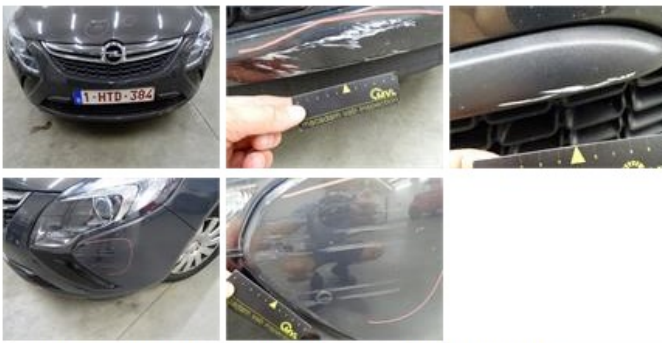
Bumper F, Scratch(es), LI - Repair and paint (complete) 211,80
