OPEL Movano 3500 MWB Med.High Roof: FA5006

Limited Technical Inspection

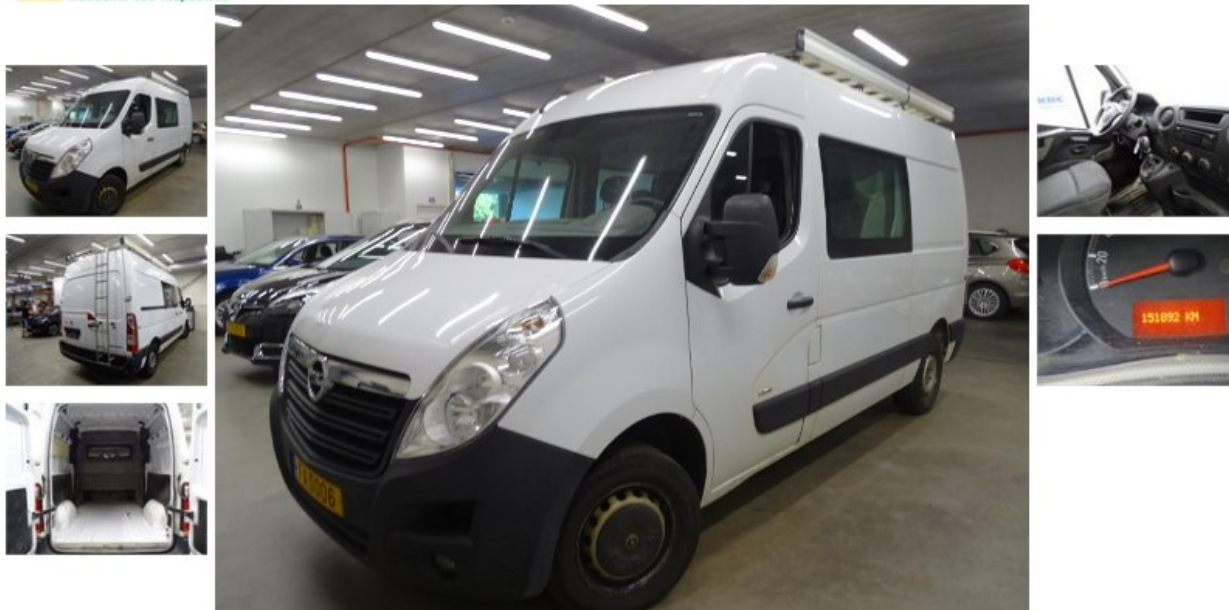
Vinnumber:	WOLMRA4RCFB072518	Versionname:	MOVANO 3500 B/F2C L2H2(E5)110PK
First Registrationdate:	23/01/2015	Fiscalpower:	
Expertise Mileage:	151892	Power Kw:	81
Bodytype:	Transporter	Body color:	White
Gearbox:	MAN 6 VIT	Paint type:	Opaque
Transmission:	Front	Rims summer:	Steel
Fueltype:	Diesel	Oil level:	OK
Battery functioning:	Yes	Parking lot:	LCV23
Number of doors:	5		
Number of seats:	7		
Number head rests:	7		
Rims summer:	Steel		
Category:	Light Commercial Vehicle		
Oil level:	OK		
Registration Certificate Car (BE):	Yes
