VOLKSWAGEN PASSAT VARIANT: 1KCE524

Limited Technical Inspection

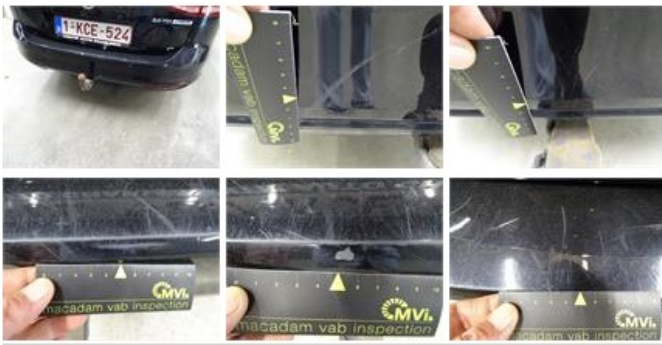
Total cost ex VAT	1544,56
Door F L, Scratch(es), Acceptable	0,00
<i>No pictures to display</i>	
Bumper R, Scratch(es), LI - Repair and paint (complete)	211,80

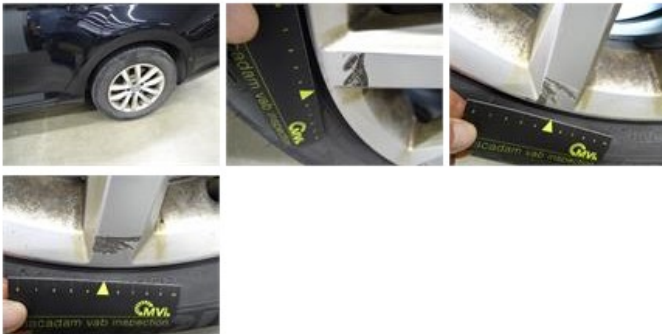
Alloy rim R L, Scratch(es), LI - Repair and paint (complete) 95,00
