RENAULT CLIO: 1KBC959

Limited Technical Inspection

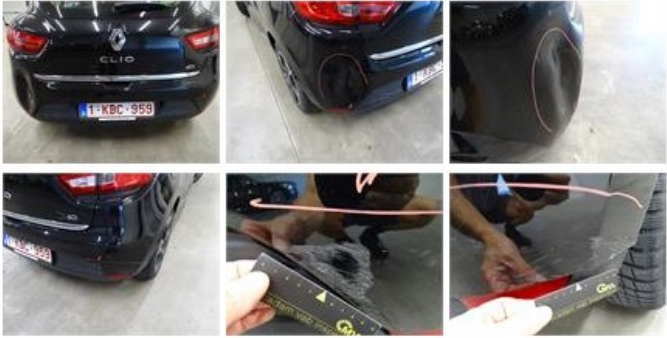
<i>No pictures to display</i>		
Roof pillar R, Dent(s), Acceptable		0,00
<i>No pictures to display</i>		
Bumper R, Dent(s) and scratch(es), Le - Replace and paint		535,20
