VOLKSWAGEN GOLF VII: 1KGN878

Limited Technical Inspection

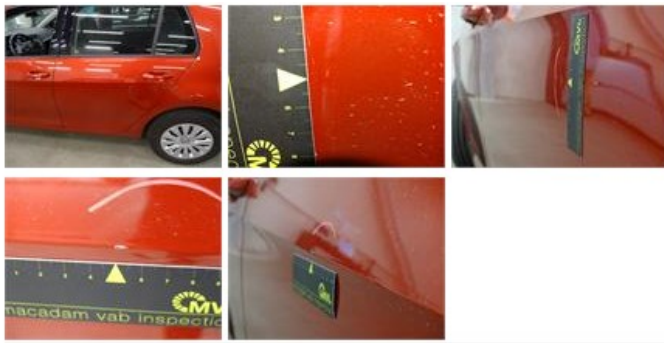
Door R L, Dent(s) and scratch(es), LI - Repair and paint (complete)	318,35
---	---------------

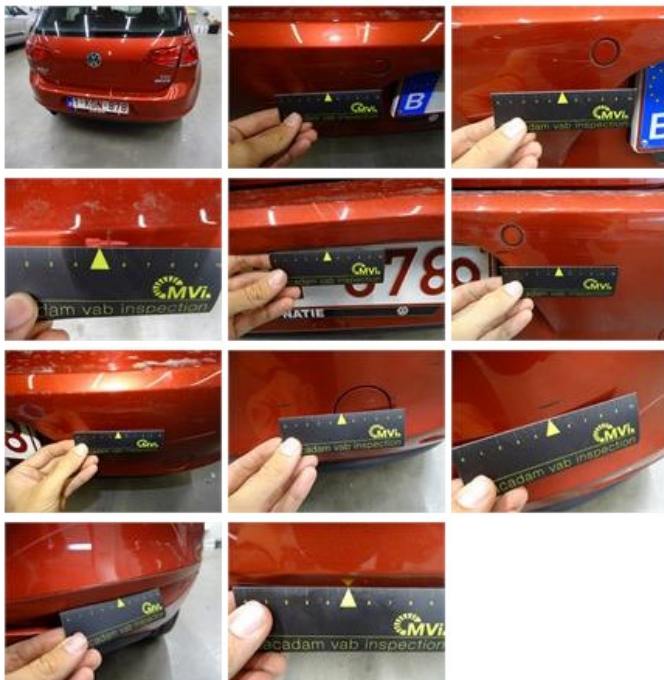
Bumper R, Scratch(es), LI - Repair and paint (complete)	211,80
---	--------
