VOLKSWAGEN Golf: 1FVN146

Vinnnumber:	WVWZZZAUZEW171588	Versionname:	GOLF BER Trendline DSG 105PK Aut.
First Registrationdate:	19/11/2013	Fiscalpower:	
Expertise Mileage:	108140	Power Kw:	77
Bodytype:	Hatchback	Body color:	Grey
Gearbox:	Automatic	Paint type:	Metalic
Transmission:		Rims summer:	Steel
Fueltype:	Petrol	Oil level:	OK
Battery functioning:	Yes	Parking lot:	1205
Number of doors:	5		
Number of seats:	5		
Number head rests:	5		
Rims summer:	Steel		
Category:	Passenger Car		
Oil level:	OK		
Registration Certificate Car (BE):	Yes

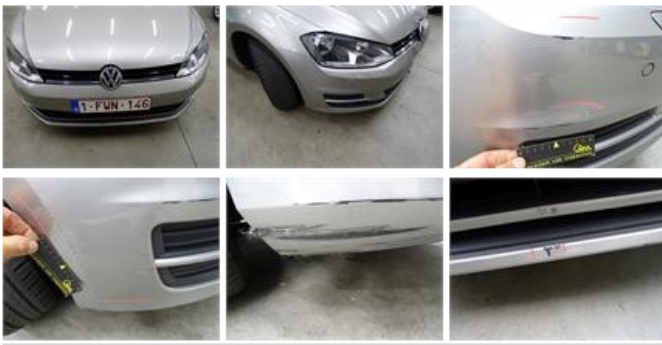
Total cost ex VAT	863,34
Bonnet, Dent(s), Acceptable	0,00
<i>No pictures to display</i>	
Bumper F, Scratch(es), LI - Repair and paint (complete)	211,80

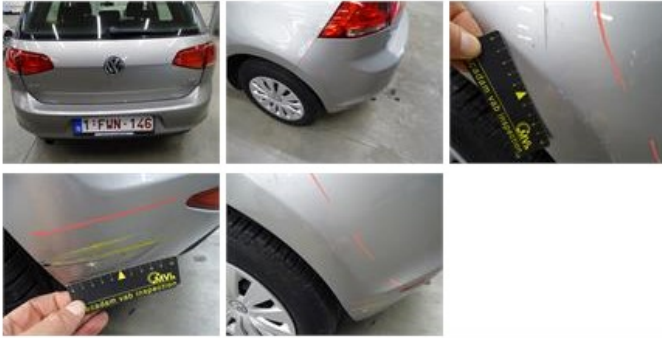
Bumper R, Scratch(es), LI - Repair and paint (complete) 211,80
