VOLVO V70: 1LPU863

Limited Technical Inspection

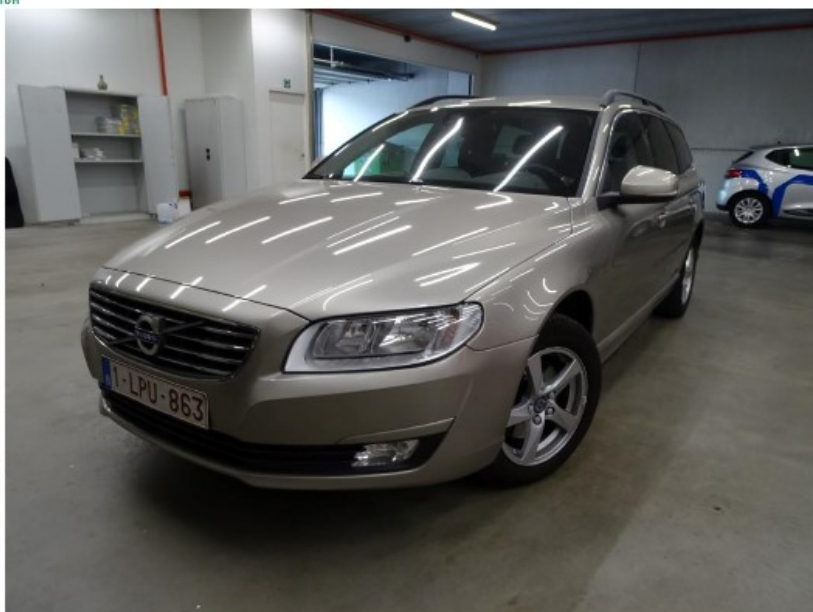
Vinnumber:	YV1BW79C1G1358294	Versionname:	2.0 D3 POLAR PLUS
First Registrationdate:	9/11/2015	Fiscalpower:	
Expertise Mileage:	134097	Power Kw:	110
Bodytype:		Body color:	Grey
Gearbox:	MAN 6 VIT	Paint type:	Metalic
Transmission:	Front	Rims summer:	Aluminium
Fueltype:	Diesel	Oil level:	OK
Maintenance:	OK	Parking lot:	2324
Battery functioning:	Yes		
Number of doors:	5		
Number of seats:	5		
Number head rests:	5		
Rims summer:	Aluminium		
Category:	Passenger Car		
Oil level:	OK		
Registration Certificate Car (BE):	Yes
