**OPEL ASTRA: AN4829**

Vinnnummer:	<b>W0LBD6EK9GG021584</b>	Versionname:	<b>1.6 CDTI 81KW ECOFLEX S/S EDITION</b>
First Registrationdate:	<b>26/11/2015</b>	Fiscalpower:	
Expertise Mileage:	<b>190647</b>	Power Kw:	<b>81</b>
Bodytype:		Body color:	<b>Grey</b>
Gearbox:	<b>MAN 6 VIT</b>	Paint type:	<b>Metalic</b>
Transmission:	<b>Front</b>	Rims summer:	<b>Aluminium</b>
Fueltype:	<b>Diesel</b>	Oil level:	<b>OK</b>
Battery functioning:	<b>Yes</b>	Parking lot:	<b>4121</b>
Number of doors:	<b>5</b>		
Number of seats:	<b>5</b>		
Number head rests:	<b>5</b>		
Rims summer:	<b>Aluminium</b>		
Category:	<b>Passenger Car</b>		
Oil level:	<b>OK</b>		
Registration Certificate Car (BE):	<b>Yes</b>

**Limited Technical Inspection**

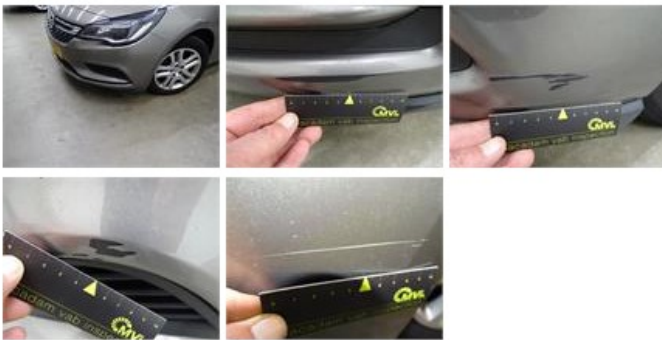
Bumper F, Scratch(es), LI - Repair and paint (complete) 211,80
