**PEUGEOT 508 SW: 1LRF798**

**Limited Technical Inspection**

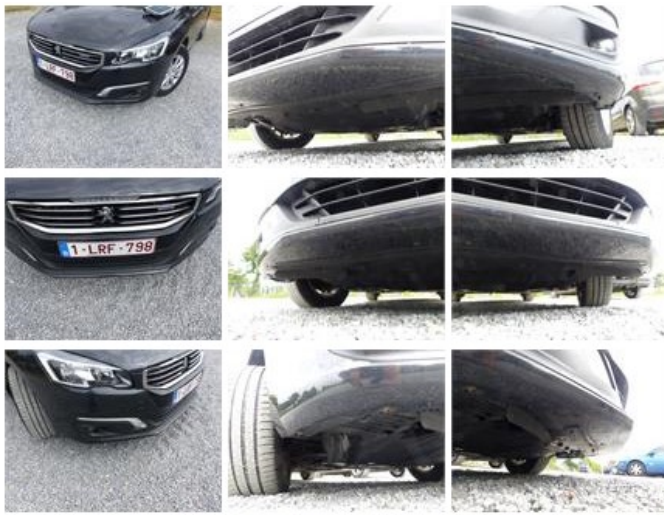
Emergency spare wheel	<b>Yes</b>	Jack	<b>Yes</b>
Total cost ex VAT			<b>648,30</b>
Bumper F, Scratch(es), LI - Repair and paint (complete)			<b>211,80</b>

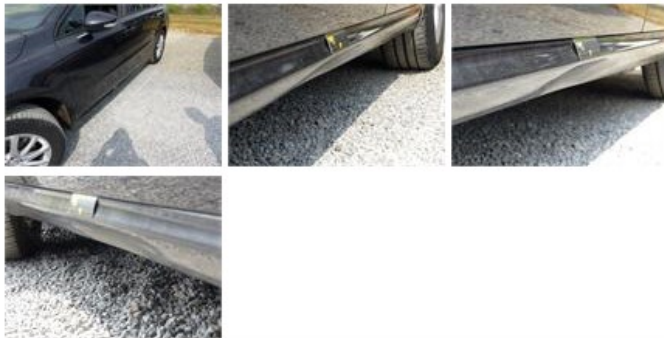
Sill outer L, Dent(s), LI - Repair and paint (complete) 310,50
