PEUGEOT 308 SW: 1KXT153

Limited Technical Inspection

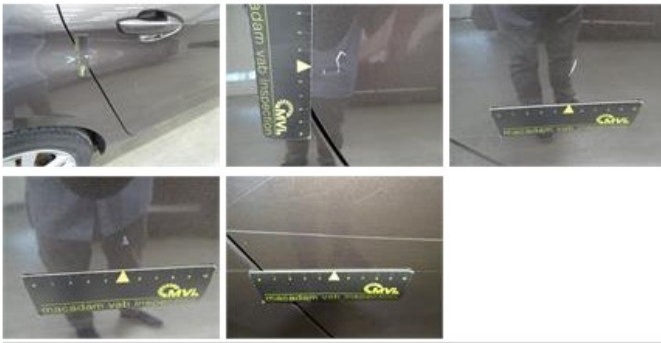
Total cost ex VAT	413,35
Bumper R, Scratch(es), Acceptable	0,00
<i>No pictures to display</i>	
Door R R, Scratch(es), LI - Repair and paint (complete)	318,35
