RENAULT Scenic: 1GVQ864

Limited Technical Inspection

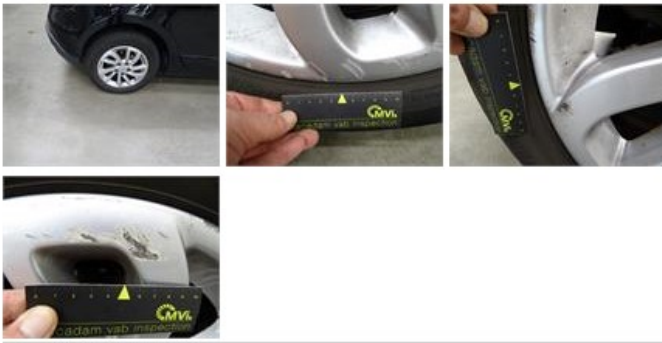
Total cost ex VAT	894,85
Alloy rim F L, Scratch(es), Acceptable	0,00
<i>No pictures to display</i>	
Alloy rim R R, Scratch(es), LI - Repair and paint (complete)	95,00

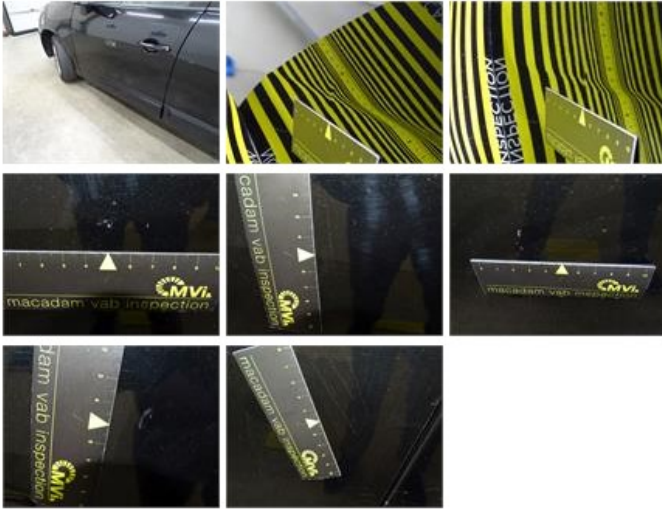
Door F L, Dent(s) and scratch(es), LI - Repair and paint (complete) 318,35
