**OPEL INSIGNIA SPORTS TOURER: 1KGT699**

**Limited Technical Inspection**

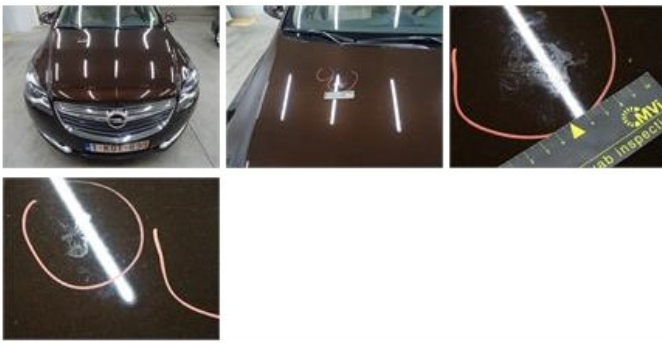
Total cost ex VAT	933,86
Alloy rim R L, Rust, Acceptable	0,00
<i>No pictures to display</i>	
Alloy rim R R, Scratch(es), Acceptable	0,00
<i>No pictures to display</i>	
Bonnet, Chemical polution, LI - Repair and paint (complete)	290,08

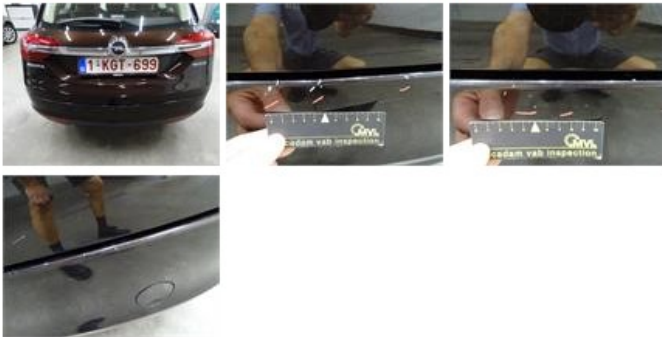
Bumper R, Scratch(es), LI - Repair and paint (complete) 211,80
