**BMW 1 HATCH: 1LEN063**

**Limited Technical Inspection**

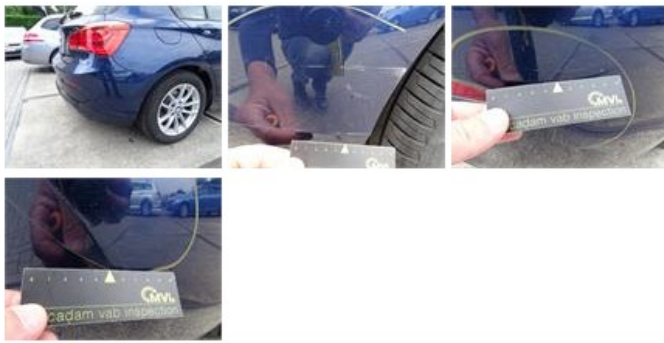
Repair kit	<b>Yes</b>	Compressor	<b>Yes</b>
Total cost ex VAT			<b>660,88</b>
Wing F L, Dent(s), Acceptable			<b>0,00</b>
<i>No pictures to display</i>			
Bumper R, Scratch(es), LI - Repair and paint (complete)			<b>211,80</b>

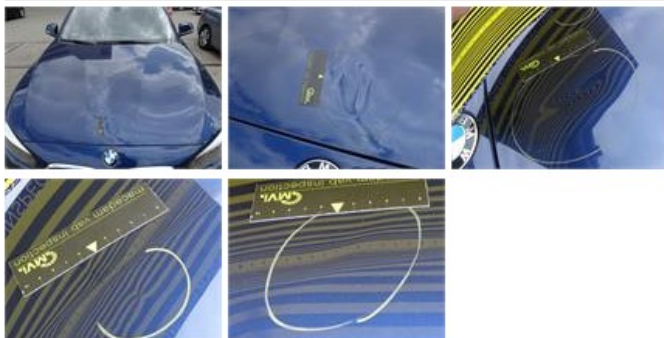
Bonnet, Dent(s), LI - Repair and paint (complete) 386,08
