DS 5: 1PLD138

Limited Technical Inspection

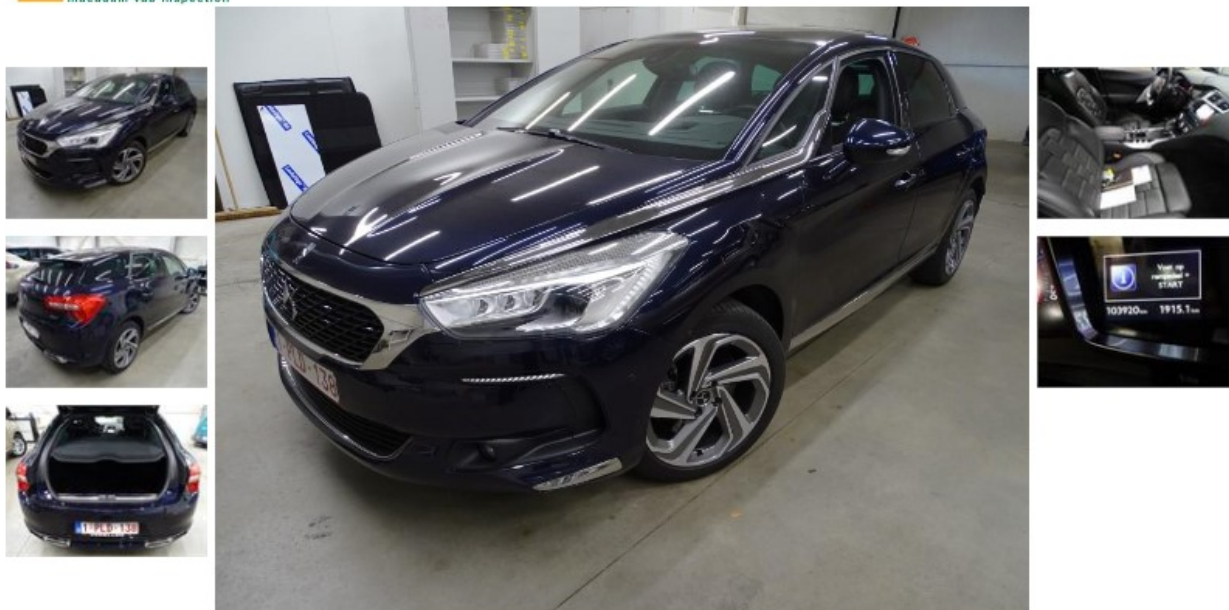
Vinnumber:	VF7KFAHWTF522266	Versionname:	2.0 BLUEHDI 180 S/S SPORT CHIC AUTO
First Registrationdate:	1/08/2016	Fiscalpower:	
Expertise Mileage:	103920	Power Kw:	133
Bodytype:		Body color:	Dark Blue
Gearbox:	Automatic	Paint type:	Metalic
Transmission:		Rims summer:	Aluminium
Fueltype:	Diesel	Oil level:	OK
Battery functioning:	Yes	Parking lot:	2508
Number of doors:	5		
Number of seats:	5		
Number head rests:	5		
Rims summer:	Aluminium		
Category:	Passenger Car		
Oil level:	OK		
Registration Certificate Car (BE):	Yes
