BMW 2 ACTIVE TOURER: 1KCL135

Limited Technical Inspection

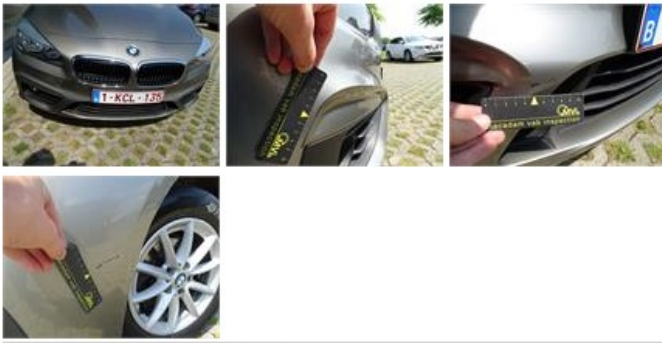
Bumper F, Scratch(es), LI - Repair and paint (complete)	211,80
---	--------
