**MERCEDES C BREAK: 1LBH052**

Vinnumber:	<b>WDD2052361F250000</b>	Versionname:	<b>1.6 C 180 BLUETEC AVANTGARDE</b>
First Registrationdate:	<b>10/08/2015</b>	Fiscalpower:	
Expertise Mileage:	<b>81219</b>	Power Kw:	<b>85</b>
Bodytype:	<b>Break</b>	Body color:	<b>Dark Grey</b>
Gearbox:	<b>Automatic</b>	Paint type:	<b>Metalic</b>
Transmission:	<b>Back</b>	Rims summer:	<b>Aluminium</b>
Fueltype:	<b>Diesel</b>	Oil level:	<b>OK</b>
Battery functioning:	<b>Yes</b>	Parking lot:	<b>3506</b>
Number of doors:	<b>5</b>		
Number of seats:	<b>5</b>		
Number head rests:	<b>5</b>		
Rims summer:	<b>Aluminium</b>		
Category:	<b>Passenger Car</b>		
Oil level:	<b>OK</b>		
Registration Certificate Car (BE):	<b>Yes</b>

**Limited Technical Inspection**

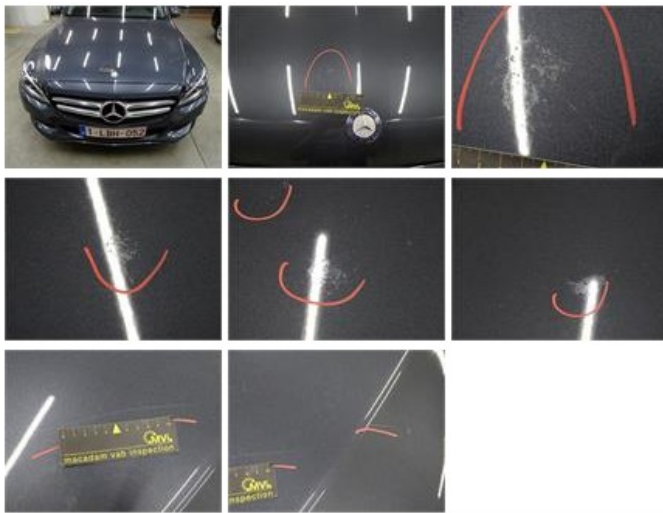
Total cost ex VAT	1059,73
Door F R, Repaired, Acceptable	0,00
<i>No pictures to display</i>	
Bonnet, Chemical polution, LI - Repair and paint (complete)	290,08
