**AUDI A3: 1GWT485**

Vinnumber:	<b>WAUZZZ8V7EA187950</b>	Versionname:	<b>A3 SB Ambiente 105PK</b>
First Registrationdate:	<b>21/05/2014</b>	Fiscalpower:	
Expertise Mileage:	<b>121082</b>	Power Kw:	<b>77</b>
Bodytype:	<b>Hatchback</b>	Body color:	<b>Grey</b>
Gearbox:	<b>MAN 6 VIT</b>	Paint type:	<b>Metalic</b>
Transmission:	<b>Front</b>	Rims summer:	<b>Aluminium</b>
Fueltype:	<b>Diesel</b>	Oil level:	<b>OK</b>
Battery functioning:	<b>Yes</b>	Parking lot:	<b>LCV</b>
Number of doors:	<b>5</b>		
Number of seats:	<b>5</b>		
Number head rests:	<b>5</b>		
Rims summer:	<b>Aluminium</b>		
Category:	<b>Passenger Car</b>		
Oil level:	<b>OK</b>		
Registration Certificate Car (BE):	<b>Yes</b>

**Limited Technical Inspection**

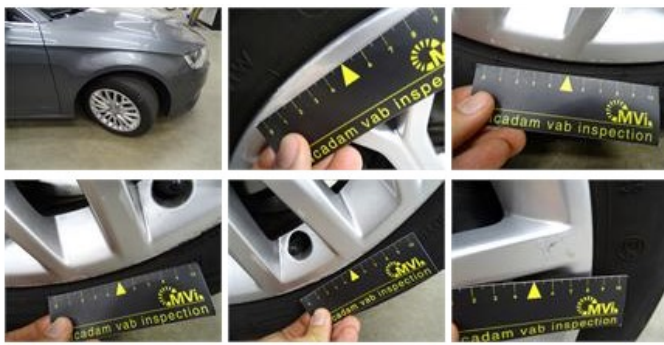
<b>Total cost ex VAT</b>	<b>1587,21</b>
<b>Alloy rim F R, Scratch(es), LI - Repair and paint (complete)</b>	<b>95,00</b>

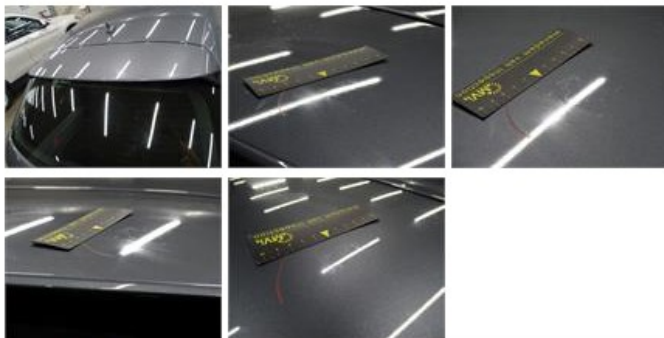
Rear spoiler, Chemical polution, LI - Repair and paint (complete)

115,56
