RENAULT Clio: 1GXZ875

Limited Technical Inspection

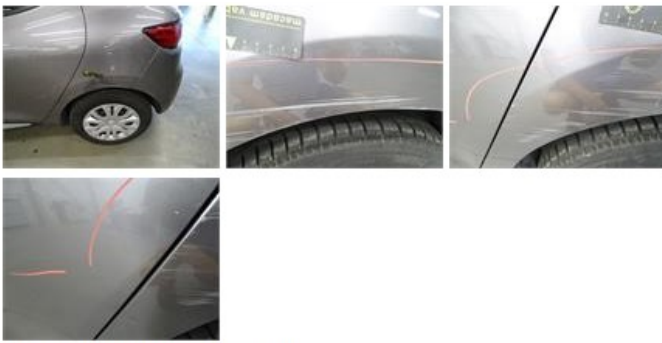
Total cost ex VAT	820,68
Wheel cover R R, Scratch(es), Acceptable	0,00
<i>No pictures to display</i>	
Ignition key, Missing, E - Replace	150,00
<i>No pictures to display</i>	
Tailgate, Scratch(es), Acceptable	0,00
<i>No pictures to display</i>	
Wing R L, Scratch(es), LI - Repair and paint (complete)	246,56

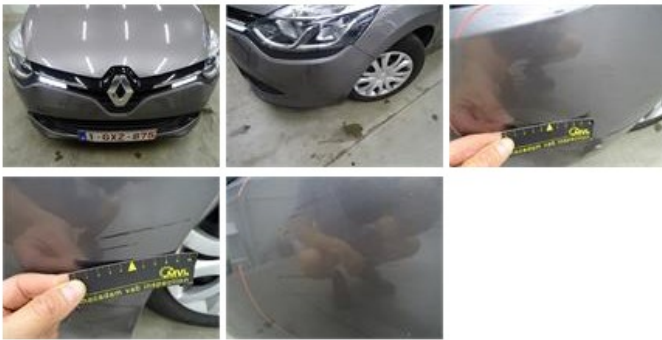
Bumper R, Scratch(es), Acceptable	0,00
<i>No pictures to display</i>	
Wheel cover F R, Scratch(es), Acceptable	0,00
<i>No pictures to display</i>	
Wing R R, Dent(s), Acceptable	0,00
<i>No pictures to display</i>	
Door R L, Scratch(es), LI - Repair and paint (complete)	254,68
