MERCEDES ML: 1HFL598

Limited Technical Inspection

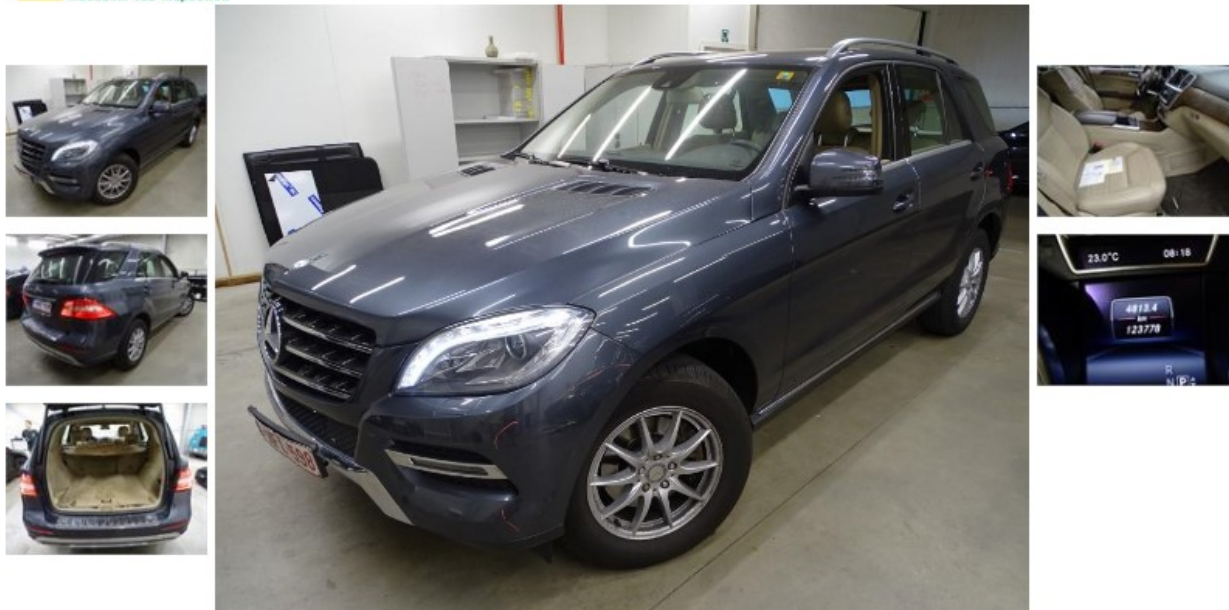
Vinnumber:	WDC1660041A422399	Versionname:	ML 250 BlueTEC 204PK Aut.
First Registrationdate:	8/07/2014	Fiscalpower:	
Expertise Mileage:	123778	Power Kw:	150
Bodytype:	SUV	Body color:	Grey
Gearbox:	Automatic	Paint type:	Metalic
Transmission:		Rims summer:	Aluminium
Fueltype:	Diesel	Oil level:	OK
Battery functioning:	Yes	Parking lot:	LCV
Number of doors:	5		
Number of seats:	5		
Number head rests:	5		
Rims summer:	Aluminium		
Category:	Passenger Car		
Oil level:	OK		
Registration Certificate Car (BE):	Yes

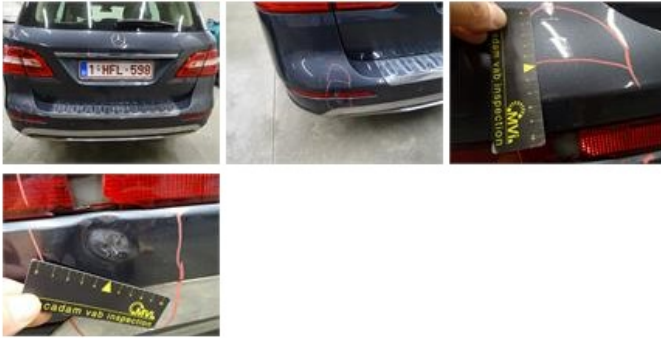
Bumper R, Dent(s) and scratch(es), LI - Repair and paint (complete)

254,16
