SKODA OCTAVIA COMBI: 1JVU024

Limited Technical Inspection

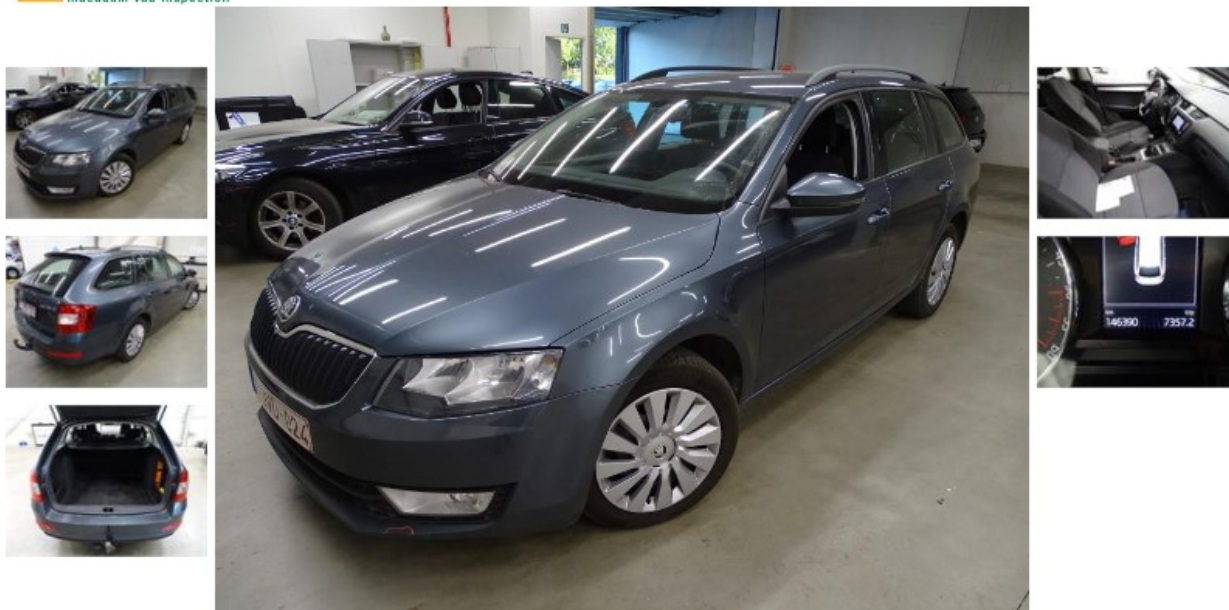
Vinnumber:	TMBJG7NE3F0181522	Versionname:	1.6 CRTDI 77KW GREENTEC AMBITION
First Registrationdate:	9/03/2015	Fiscalpower:	
Expertise Mileage:	146390	Power Kw:	77
Bodytype:	Break	Body color:	Grey
Gearbox:	MAN 5 VIT	Paint type:	Metalic
Transmission:		Rims summer:	Steel
Fueltype:	Diesel	Oil level:	OK
Battery functioning:	Yes	Parking lot:	1428
Number of doors:	5		
Number of seats:	5		
Number head rests:	5		
Rims summer:	Steel		
Category:	Passenger Car		
Oil level:	OK		
Registration Certificate Car (BE):	Yes
