MINI : 1KFG991			
Vinnumber:	WMWXT110702B77319	Versionname:	1.5 ONE D
First Registrationdate:	21/04/2015	Fiscalpower:	
Expertise Mileage:	97349	Power Kw:	70
Bodytype:	Hatchback	Body color:	Green
Gearbox:	MAN 6 VIT	Paint type:	Metalic
Transmission:		Rims summer:	Aluminium
Fueltype:	Diesel	Oil level:	OK
Battery functioning:	Yes	Parking lot:	3712
Number of doors:	5		
Number of seats:	5		
Number head rests:	5		
Rims summer:	Aluminium		
Category:	Passenger Car		
Oil level:	OK		
Registration Certificate Car (BE):	Yes

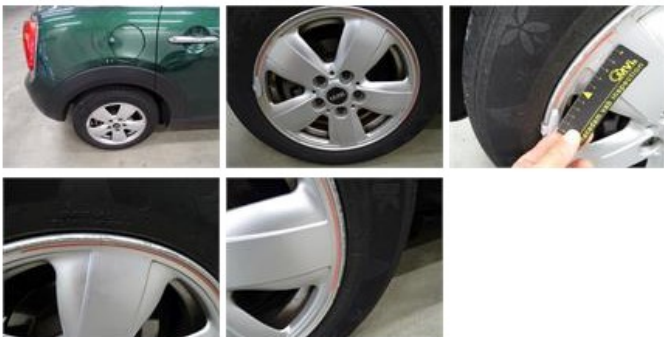
Alloy rim R R, Scratch(es), LI - Repair and paint (complete)	95,00
--------------------------------------------------------------	-------

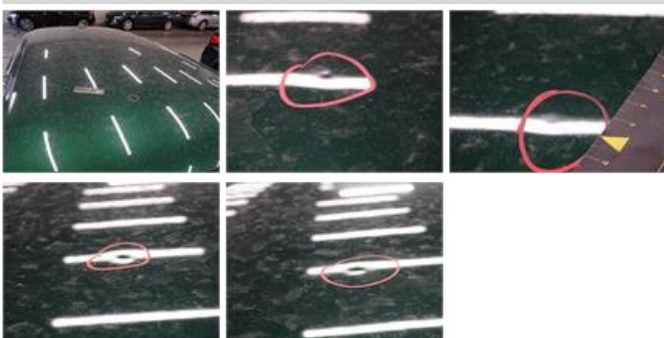
Roof, Dent(s), PDR - Paintless dent repair	122,40
--------------------------------------------	--------

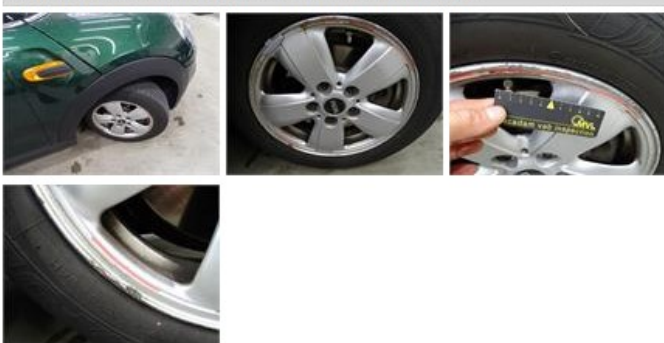
Alloy rim F R, Scratch(es), LI - Repair and paint (complete)	95,00
--------------------------------------------------------------	-------
