**FORD S Max: 1JGF473**

Vinnumber:	<b>WF05XXGBWSEA11523</b>	Versionname:	<b>S-MAX Trend Style St/St DPF 115PK</b>
First Registrationdate:	<b>10/12/2014</b>	Fiscalpower:	
Expertise Mileage:	<b>121822</b>	Power Kw:	<b>85</b>
Bodytype:		Body color:	<b>Silver</b>
Gearbox:	<b>MAN 6 VIT</b>	Paint type:	<b>Metalic</b>
Transmission:	<b>Front</b>	Rims summer:	<b>Aluminium</b>
Fueltype:	<b>Diesel</b>	Oil level:	<b>OK</b>
Battery functioning:	<b>Yes</b>	Parking lot:	<b>2625</b>
Number of doors:	<b>5</b>		
Number of seats:	<b>7</b>		
Number head rests:	<b>7</b>		
Rims summer:	<b>Aluminium</b>		
Category:	<b>Passenger Car</b>		
Oil level:	<b>OK</b>		
Registration Certificate Car (BE):	<b>Yes</b>

**Limited Technical Inspection**

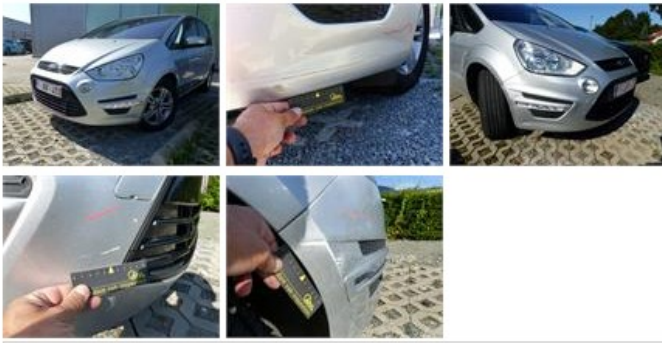
Total cost ex VAT		1353,78
Door trim F L, Scratch(es), Acceptable		0,00
<i>No pictures to display</i>		
Bumper F, Scratch(es), LI - Repair and paint (complete)		254,16

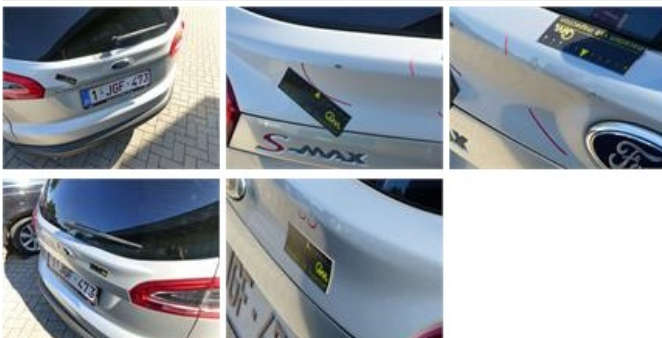
Tailgate, Dent(s) and scratch(es), LI - Repair and paint (complete) 410,02
