**VOLKSWAGEN Passat: 1GRE901**

**Limited Technical Inspection**

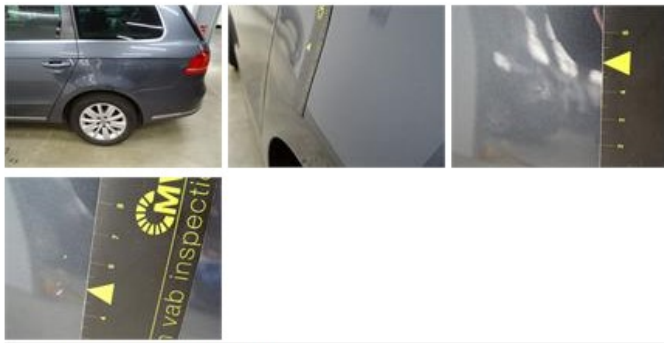
Total cost ex VAT	<b>636,70</b>
Wing R L, Dent(s) and scratch(es), Acceptable	<b>0,00</b>

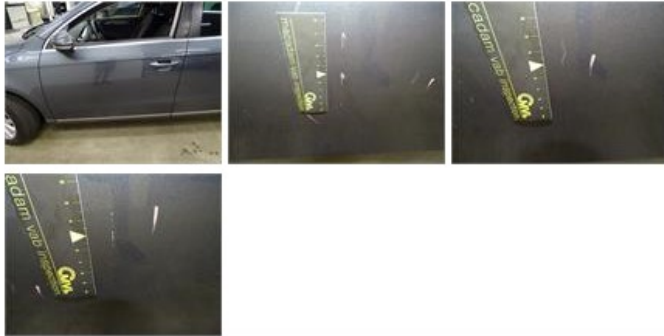
Seat cover R R, Stain, Acceptable	0,00
<i>No pictures to display</i>	
Door F L, Scratch(es), LI - Repair and paint (complete)	318,35

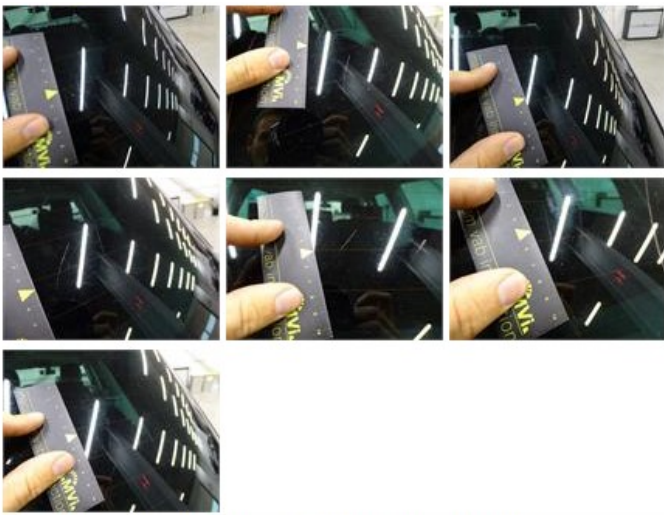
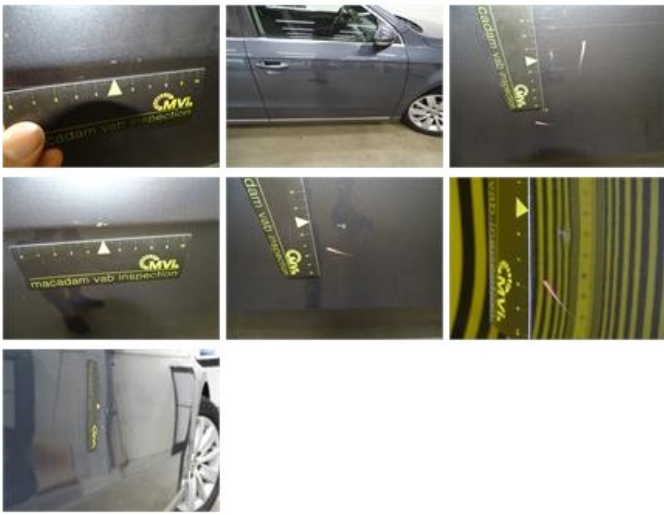
Door F R, Dent(s) and scratch(es), LI - Repair and paint (complete)

318,35
