VOLVO S60: 1KFJ967

Limited Technical Inspection

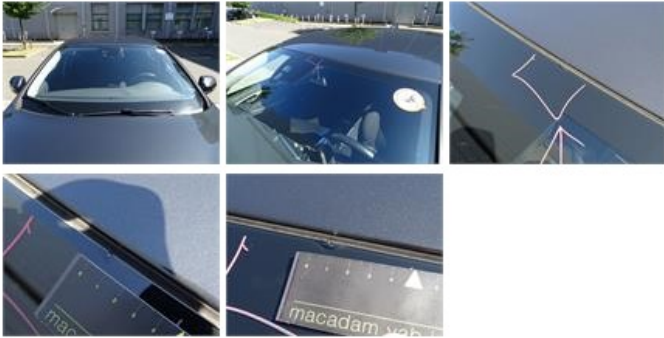
Rearview mirror housing L, Scratch(es), Acceptable	0,00
<i>No pictures to display</i>	
Alloy rim R R, Scratch(es), Acceptable	0,00
<i>No pictures to display</i>	
Windscreen, Stone chip(s), E - Replace	487,20

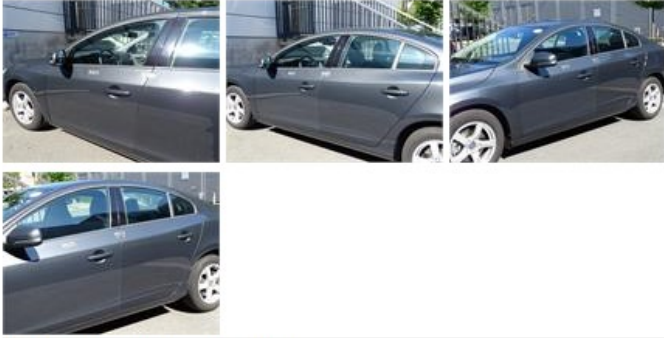
Door F L, Bad repair, P - Check	0,00
