VOLVO V60: 1JXB692

Limited Technical Inspection

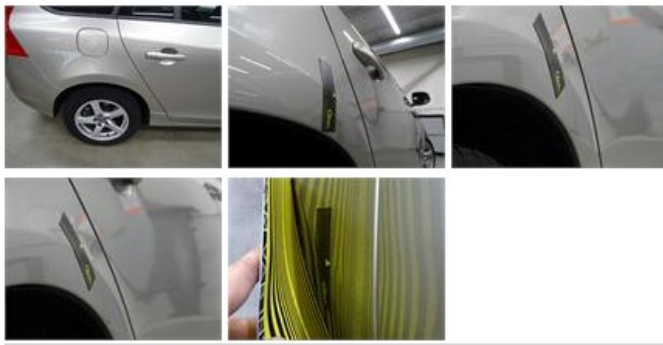
Total cost ex VAT	464,80
Wing R R, Dent(s), PDR - Paintless dent repair	63,00

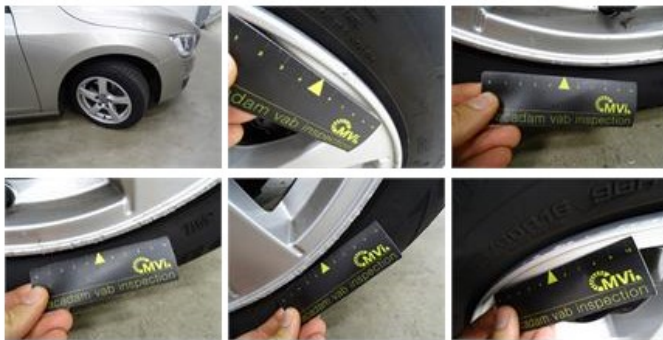
Headlight L, Scratch(es), Acceptable	0,00
<i>No pictures to display</i>	
Door R R, Scratch(es), Acceptable	0,00
<i>No pictures to display</i>	
Rearview mirror housing R, Scratch(es), Acceptable	0,00
<i>No pictures to display</i>	
Wing F R, Scratch(es), Acceptable	0,00
<i>No pictures to display</i>	
Rear spoiler, Dent(s), Acceptable	0,00
<i>No pictures to display</i>	
Door F L, Dent(s) and scratch(es), Acceptable	0,00
<i>No pictures to display</i>	
Alloy rim F R, Scratch(es), LI - Repair and paint (complete)	95,00

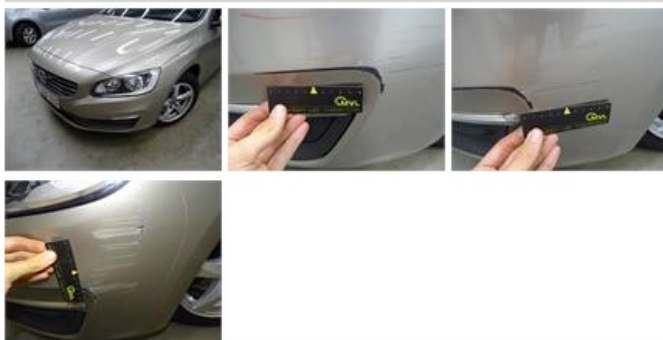
Bumper F, Scratch(es), LI - Repair and paint (complete)	211,80
---	--------

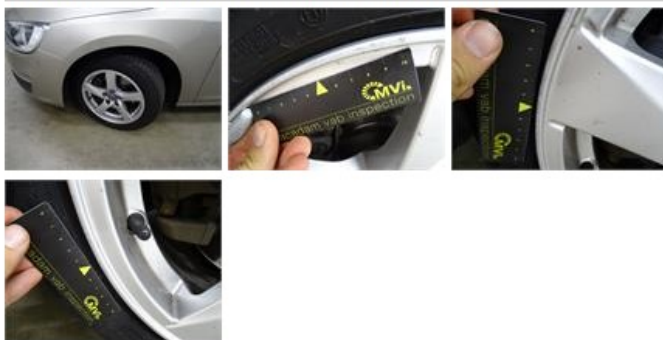
Door panel R L, Scratch(es), Acceptable	0,00
<i>No pictures to display</i>	
Bumper R, Scratch(es), Acceptable	0,00
<i>No pictures to display</i>	
Alloy rim F L, Scratch(es), LI - Repair and paint (complete)	95,00
