**MERCEDES A: 1HKL214**

**Limited Technical Inspection**

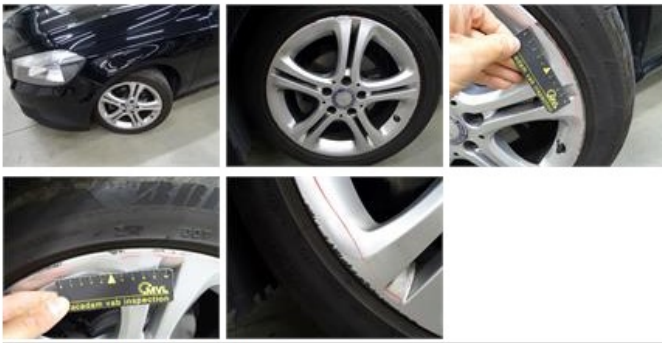
<b>Total cost ex VAT</b>	<b>190,00</b>
<b>Wing R L, Dent(s), Acceptable</b>	<b>0,00</b>
<i>No pictures to display</i>	
<b>Alloy rim R R, Scratch(es), Acceptable</b>	<b>0,00</b>
<i>No pictures to display</i>	
<b>Bonnet, Stone chip(s), Acceptable</b>	<b>0,00</b>
<i>No pictures to display</i>	
<b>Alloy rim F L, Scratch(es), LI - Repair and paint (complete)</b>	<b>95,00</b>

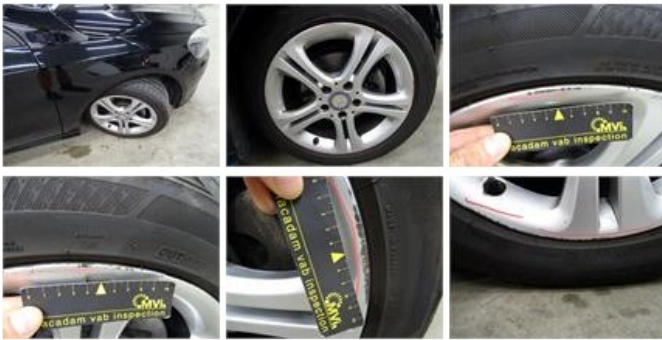
Door F L, Dent(s), Acceptable	0,00
<i>No pictures to display</i>	
Bumper F, Stone chip(s), Acceptable	0,00
<i>No pictures to display</i>	
Door R R, Scratch(es), Acceptable	0,00
<i>No pictures to display</i>	
Alloy rim R L, Scratch(es), Acceptable	0,00
<i>No pictures to display</i>	
Alloy rim F R, Scratch(es), LI - Repair and paint (complete)	95,00
