TOYOTA YARIS: 1KGR621

Limited Technical Inspection

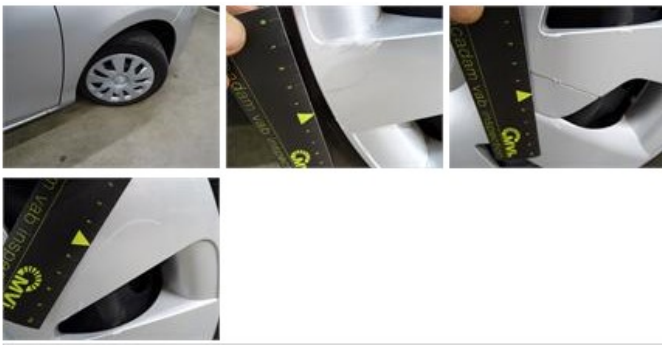
Total cost ex VAT	0,00
Bodywork, Not original part, Acceptable	0,00
<i>No pictures to display</i>	
Wheel cover F R, Scratch(es), E - Replace	0,00

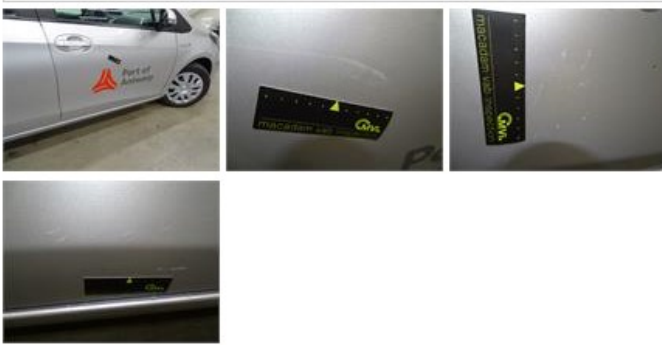
Door F R, Scratch(es), LI - Repair and paint (complete)	0,00
---	------
