PEUGEOT 308: 1GNT745

Limited Technical Inspection

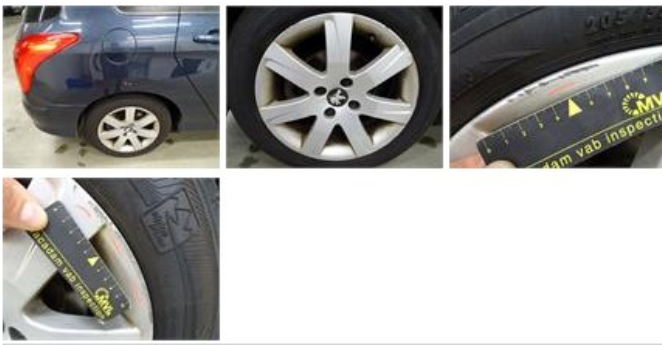
Total cost ex VAT	285,00
Wing F L, Scratch(es), Acceptable	0,00
<i>No pictures to display</i>	
Alloy rim R R, Scratch(es), LI - Repair and paint (complete)	95,00

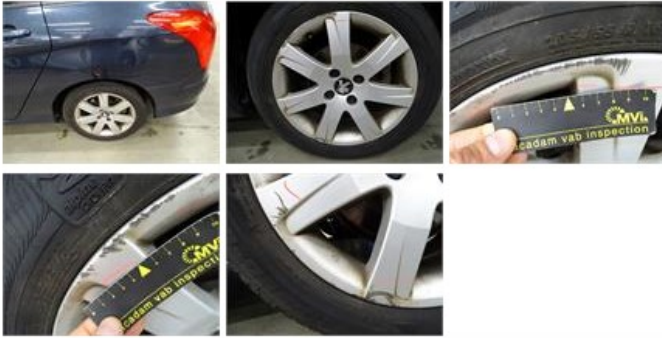
Alloy rim R L, Scratch(es), LI - Repair and paint (complete)	95,00
--------------------------------------------------------------	-------

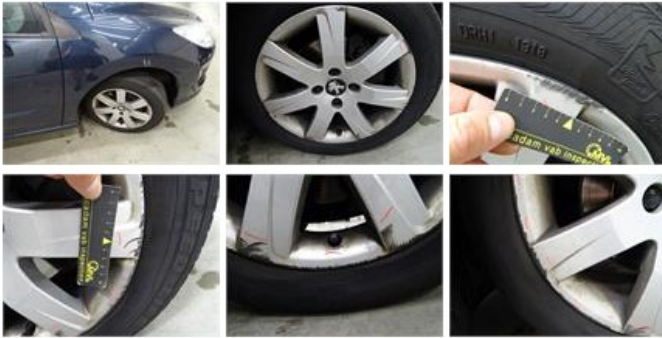
Alloy rim F R, Scratch(es), LI - Repair and paint (complete)	95,00
--------------------------------------------------------------	-------
