BMW X1: 1HHP964

Limited Technical Inspection

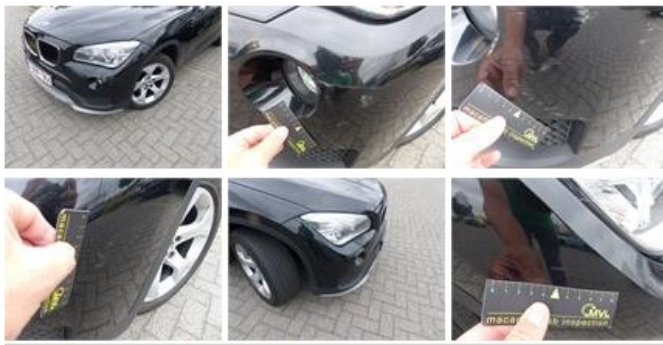
Bumper F, Scratch(es), LI - Repair and paint (complete)	211,80
---	---------------

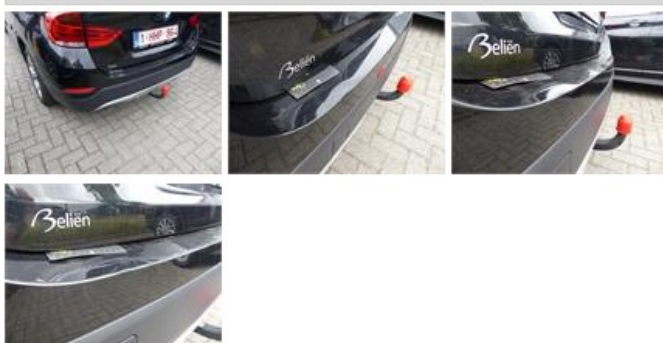
Door F L, Scratch(es), Acceptable	0,00
<i>No pictures to display</i>	
Door R L, Dent(s) and scratch(es), Acceptable	0,00
<i>No pictures to display</i>	
Bonnet, Chemical pollution, Acceptable	0,00
<i>No pictures to display</i>	
Bumper R, Dent(s) and scratch(es), LI - Repair and paint (complete)	259,80
