BMW 3 GRAN TURISMO: 1LBS823

Limited Technical Inspection

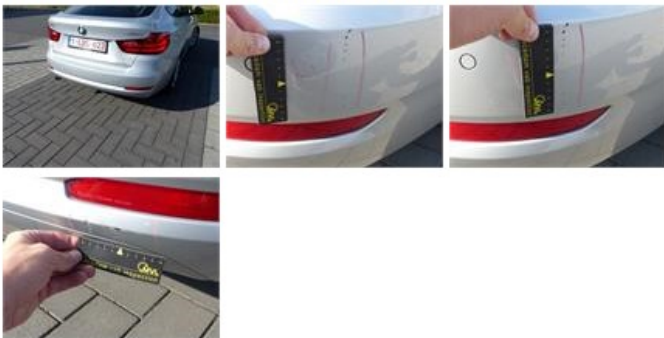
Alloy rim F R, Scratch(es), Acceptable		0,00
<i>No pictures to display</i>		
Maintenance book, Missing, Acceptable		0,00
<i>No pictures to display</i>		
Door F L, Scratch(es), Acceptable		0,00
<i>No pictures to display</i>		
Door R L, Dent(s) and scratch(es), Acceptable		0,00
<i>No pictures to display</i>		
Door panel R L, Scratch(es), Acceptable		0,00
<i>No pictures to display</i>		
Bodywork, Not original part, Acceptable		0,00
<i>No pictures to display</i>		
Door F R, Dent(s), Acceptable		0,00
<i>No pictures to display</i>		
Bumper R, Dent(s) and scratch(es), LI - Repair and paint (complete)		211,80
