**VOLKSWAGEN PASSAT VARIANT: 1JGR863**

**Limited Technical Inspection**

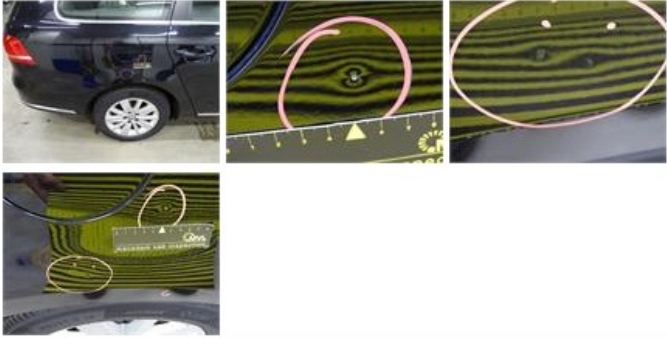
Wing F L, Scratch(es), Acceptable	0,00
<i>No pictures to display</i>	
Door F L, Scratch(es), Acceptable	0,00
<i>No pictures to display</i>	
Wing R R, Dent(s) and scratch(es), LI - Repair and paint (complete)	308,20
