BMW 3: 1JLG458

Limited Technical Inspection

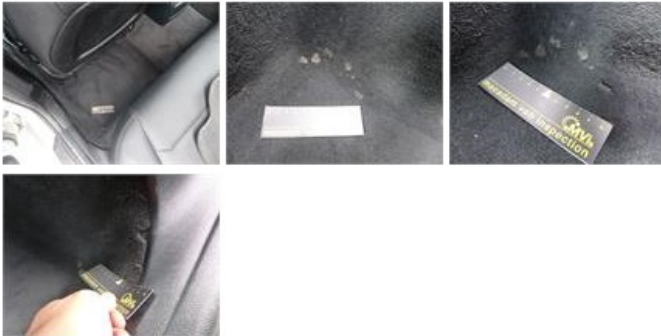
Door F L, Dent(s) and scratch(es), Acceptable	0,00
<i>No pictures to display</i>	
Outer backrest protection R, Scratch(es), Acceptable	0,00
<i>No pictures to display</i>	
Wing R L, Dent(s), Acceptable	0,00
<i>No pictures to display</i>	
Bonnet, Scratch(es), Acceptable	0,00
<i>No pictures to display</i>	
Floor covering R, Damaged, E - Replace	252,00
