OPEL Zafira: 1GWN861

Limited Technical Inspection

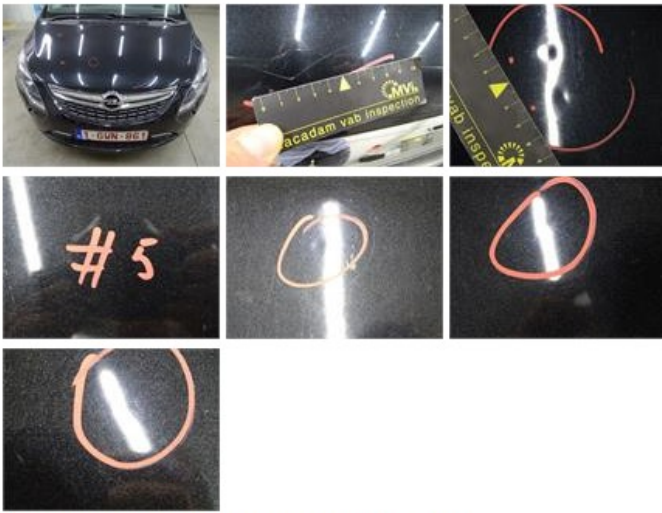
Total cost ex VAT	921,58
Certificate Of Conformity, Missing, E - Replace	150,00
<i>No pictures to display</i>	
Wing R L, Scratch(es), 67 - Polish	0,00
<i>No pictures to display</i>	
Wing R L, Dent(s), Acceptable	0,00
<i>No pictures to display</i>	
Bonnet, Dent(s) and scratch(es), LI - Repair and paint (complete)	290,08
