OPEL Astra: 1HFG465

Limited Technical Inspection

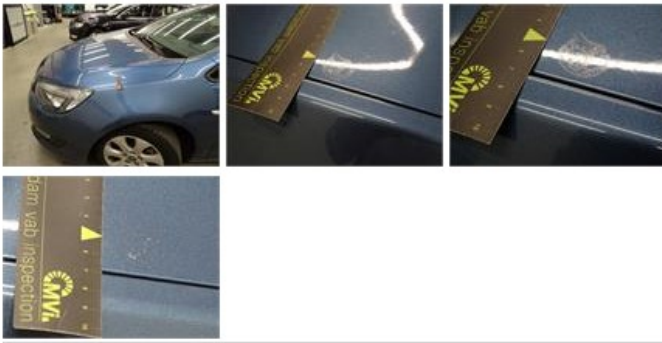
Total cost ex VAT	290,08
Tailgate, Dent(s) and scratch(es), Acceptable	0,00
<i>No pictures to display</i>	
Seat cover F L, Worn, Acceptable	0,00
<i>No pictures to display</i>	
Bonnet, Chemical polution, LI - Repair and paint (complete)	290,08
