MERCEDES CLA SHOOTING BRAKE: 1KJU567

Limited Technical Inspection

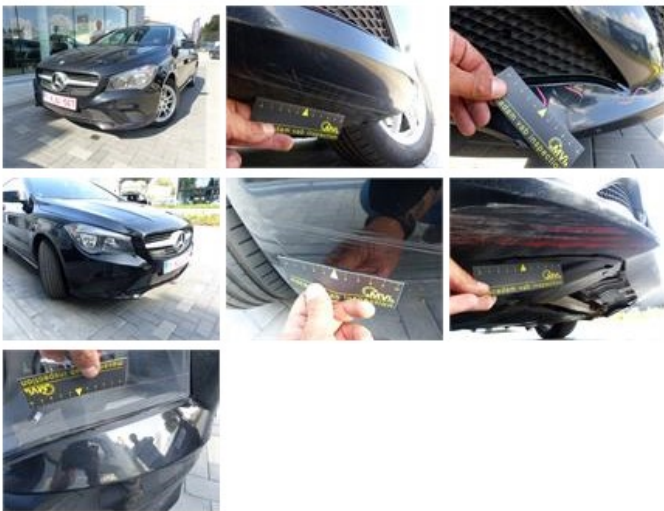
Trunk lid covering R, Scratch(es), Acceptable	0,00
<i>No pictures to display</i>	
Bumper F, Dent(s) and scratch(es), LI - Repair and paint (complete)	211,80

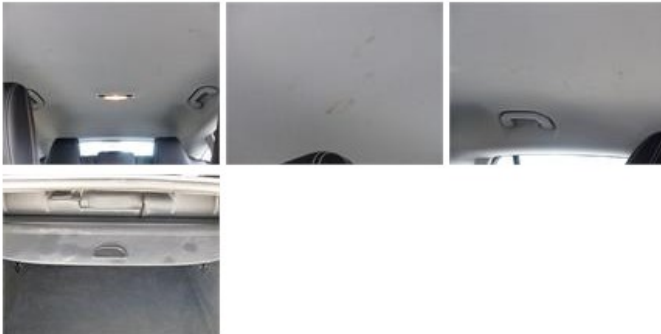
Interior, Dirty, Cleaning 25,00
