OPEL ASTRA SPORTS TOURER: 1LCK286

Limited Technical Inspection

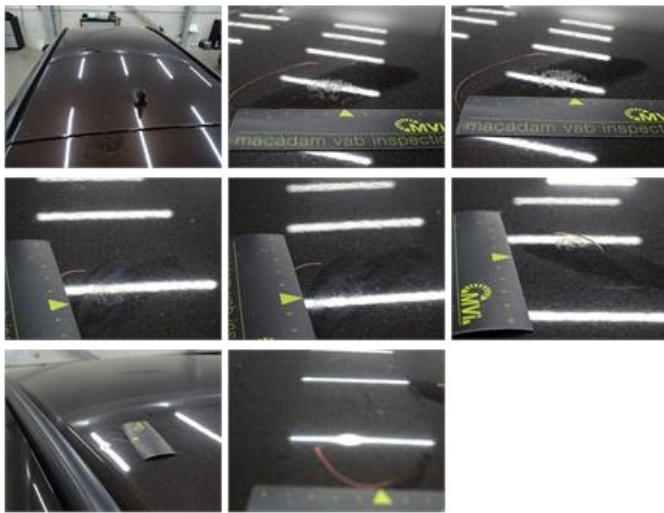
Total cost ex VAT	1089,70
Roof, Chemical polution, LI - Repair and paint (complete)	481,50

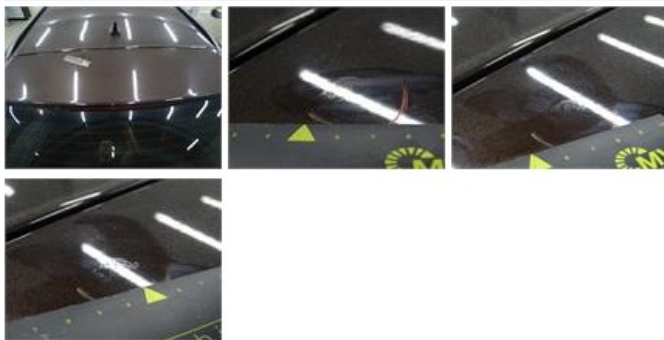
Bumper R, Scratch(es), Acceptable	0,00
<i>No pictures to display</i>	
Wing R R, Scratch(es), Acceptable	0,00
<i>No pictures to display</i>	
Wing R L, Scratch(es), Acceptable	0,00
<i>No pictures to display</i>	
Rear spoiler, Chemical polution, LI - Repair and paint (complete)	115,56

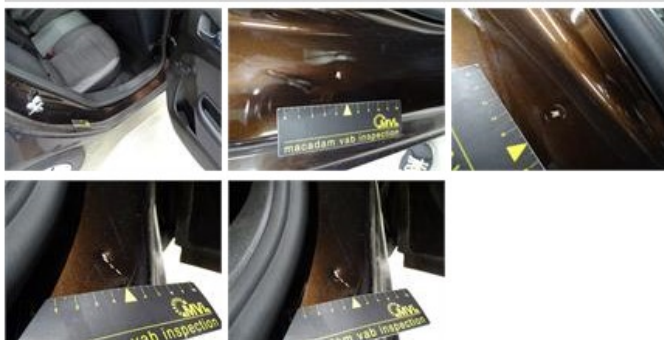
Door R L, Scratch(es), Acceptable	0,00
<i>No pictures to display</i>	
Wing F L, Scratch(es), Acceptable	0,00
<i>No pictures to display</i>	
A-Pillar left, Dent(s), Acceptable	0,00
<i>No pictures to display</i>	
Rocker panel inner R R, Dent(s), LI - Repair and paint (complete)	115,56

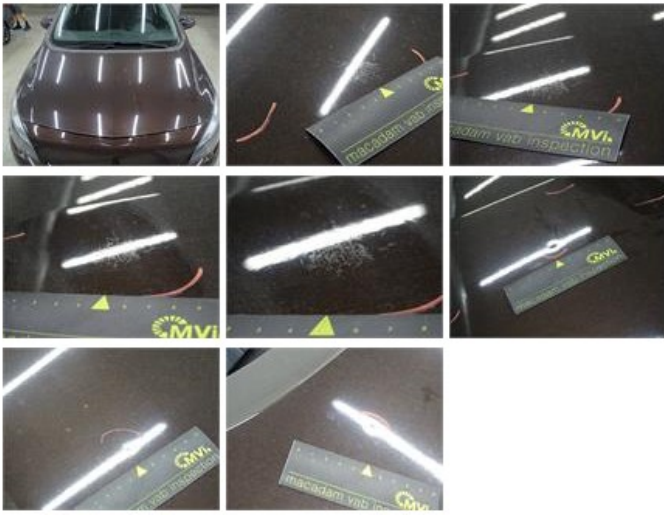
Wheel cover F R, Scratch(es), Acceptable	0,00
<i>No pictures to display</i>	
Bonnet, Chemical polution, LI - Repair and paint (complete)	314,08
