PEUGEOT 5008: PK8387

Limited Technical Inspection

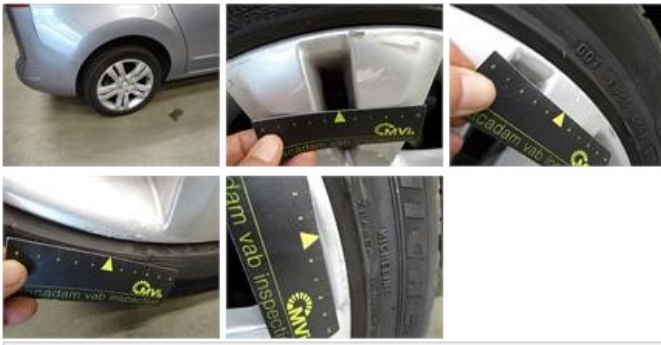
Alloy rim R R, Scratch(es), L L, Repair and paint (complete)	0,00
--	-------------

Alloy rim R R, Scratch(es), LI - Repair and paint (complete)

95,00

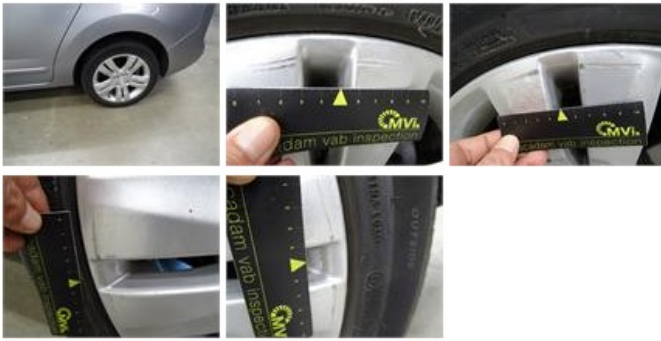
Alloy rim R L, Scratch(es), LI - Repair and paint (complete)

95,00
