MINI ONE: 1PGX313

Limited Technical Inspection

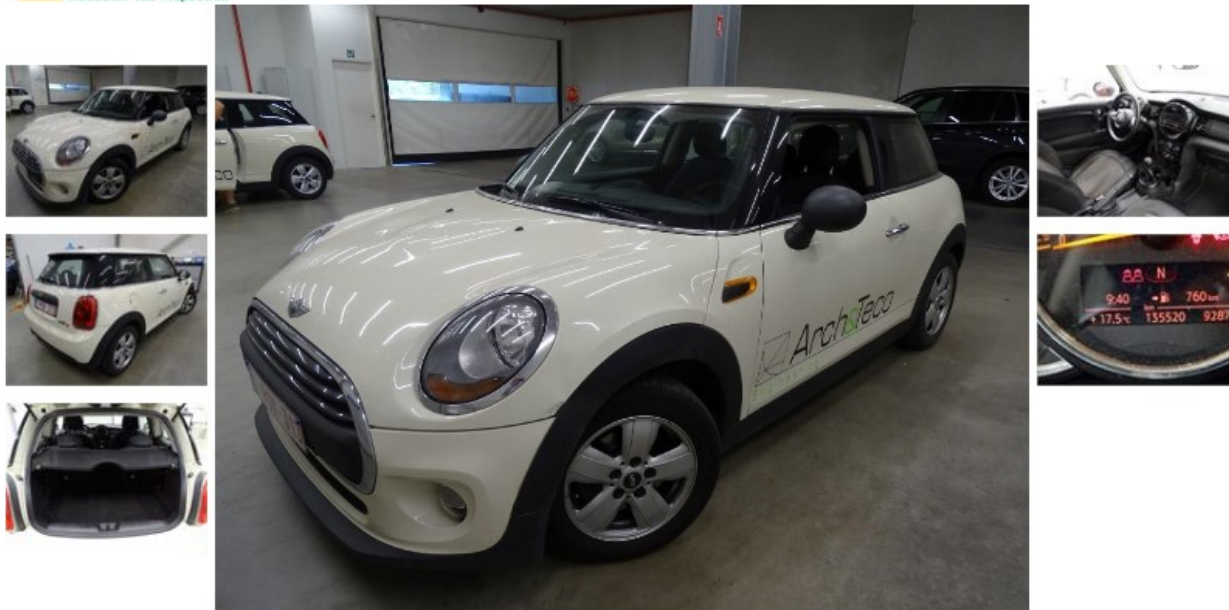
Vinnumber:	WMWXN110803A01111	Versionname:	
First Registrationdate:	12/10/2014	Fiscalpower:	
Expertise Mileage:	135520	Power Kw:	70
Bodytype:		Body color:	White
Gearbox:	MAN 6 VIT	Paint type:	Metalic
Transmission:	Front	Rims summer:	Aluminium
Fueltype:	Diesel	Oil level:	OK
Battery functioning:	Yes	Parking lot:	2122
Number of doors:	3		
Number of seats:	4		
Number head rests:	4		
Rims summer:	Aluminium		
Category:	Passenger Car		
Oil level:	OK		
Registration Certificate Car (BE):	Yes
