RENAULT Scenic: 1KGZ78

Limited Technical Inspection

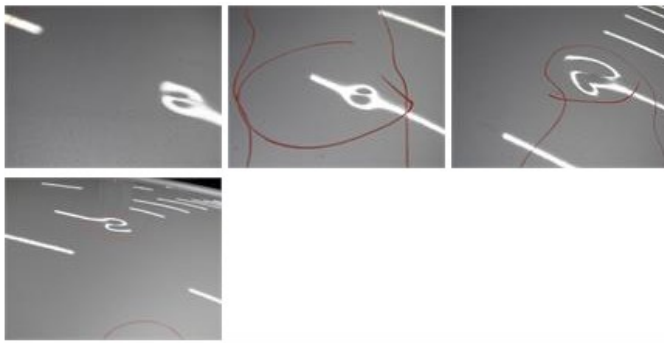
Roof, Dent(s) and scratch(es), LI - Repair and paint (complete) 481,50

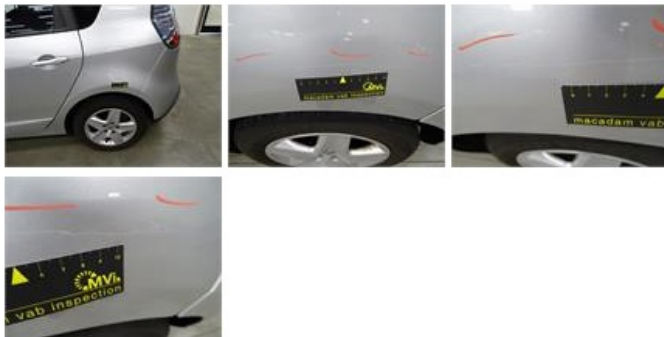
Bonnet, Dent(s), Acceptable	0,00
<i>No pictures to display</i>	
Wheel cover F R, Scratch(es), Acceptable	0,00
<i>No pictures to display</i>	
Wing R L, Scratch(es), LI - Repair and paint (complete)	308,20
